HUD CAPITAL NEEDS ASSESSMENT

Silverada Manor
1402 Silverada Boulevard
Reno, Nevada 89512

AEI Project No. 459084
Site Inspection Date: May 18, 2022

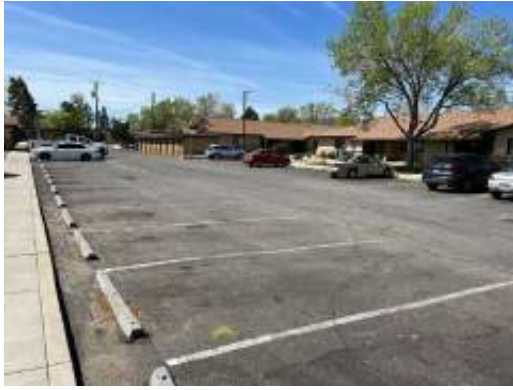
Parking Lot - Worn seal coat and faded striping (Non-Critical Repair)

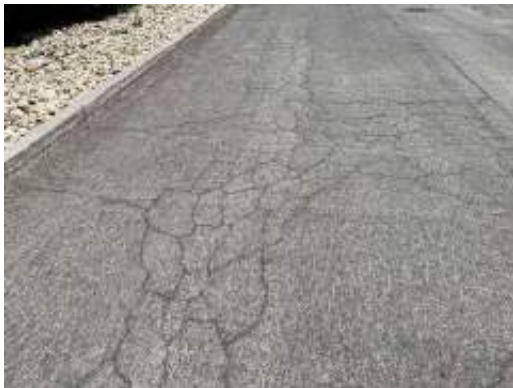
Asphalt Condition (Non-Critical Repair)

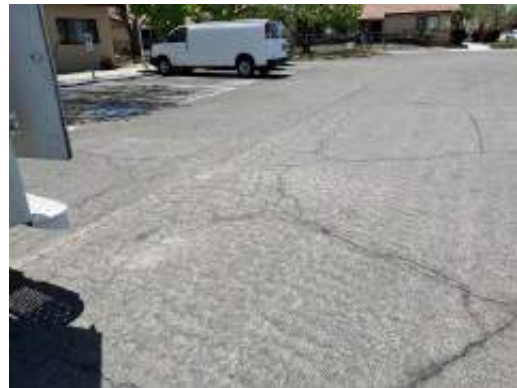
Asphalt Cracking at Community Center Parking Lot (Non-Critical Repair)

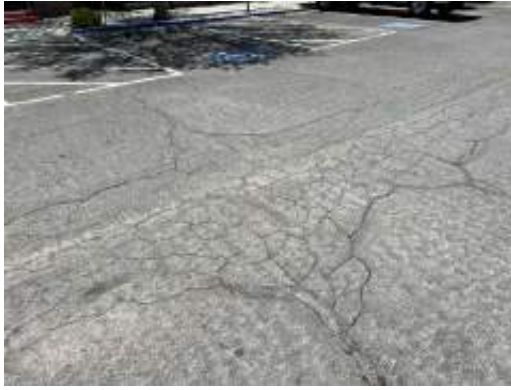
Asphalt Cracking at Community Center
Parking Lot (Non-Critical Repair)

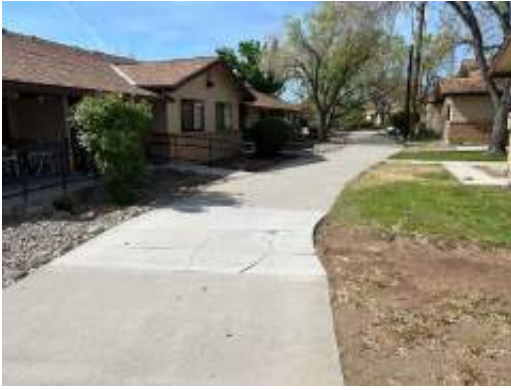
Cracked Sidewalk Near Building 4 (Critical Repair)

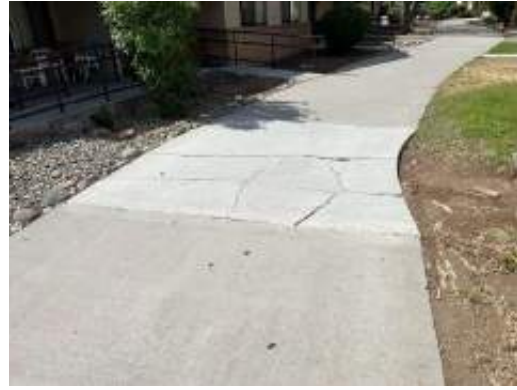
Cracked Sidewalk Near Building 4 (Critical Repair)

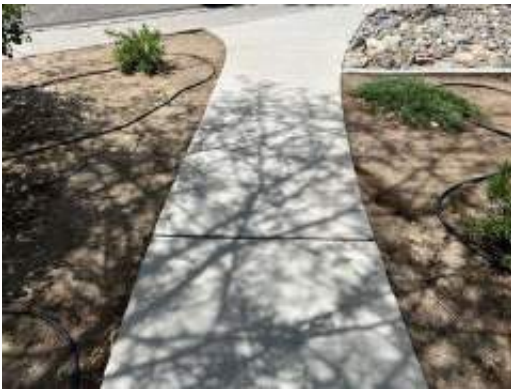
Trip Hazard at Sidewalk Near Building 16 (Critical Repair)

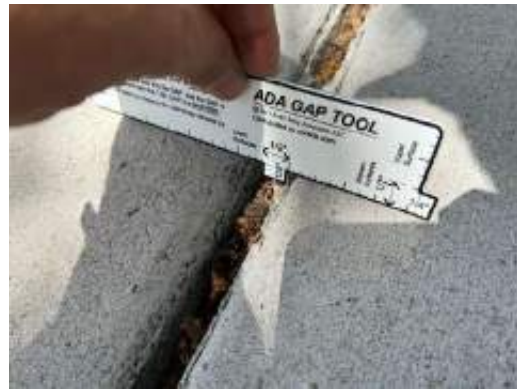
Trip Hazard at Sidewalk Near Building 16 (Critical Repair)

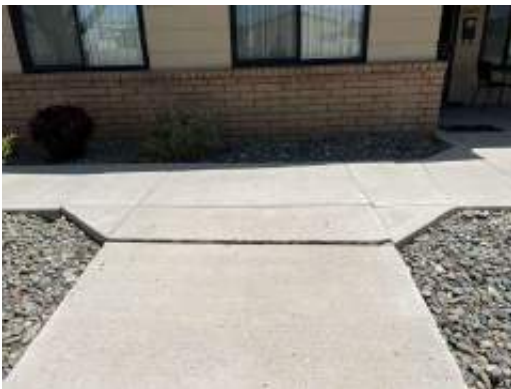
Trip Hazard at Sidewalk Near Building 1 (Critical Repair)

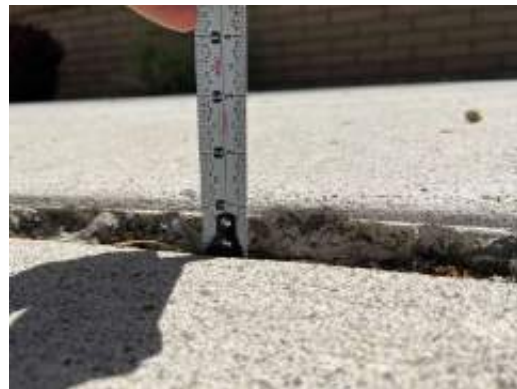
Trip Hazard at Sidewalk Near Building 1 (Critical Repair)

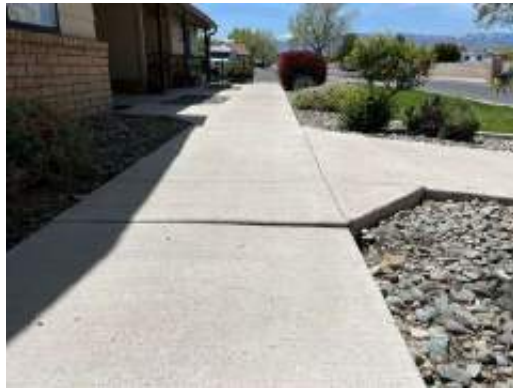
Trip Hazard at Sidewalk Near Building 1
(Critical Repair)

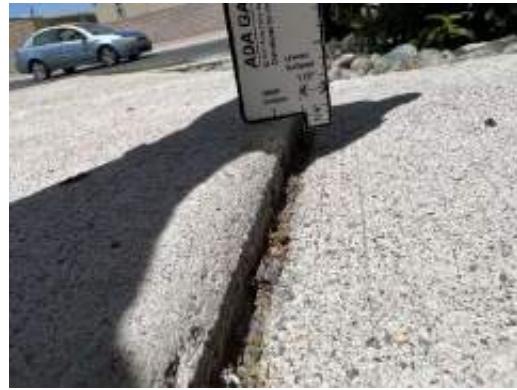
Trip Hazard at Sidewalk Near Building 1
(Critical Repair)

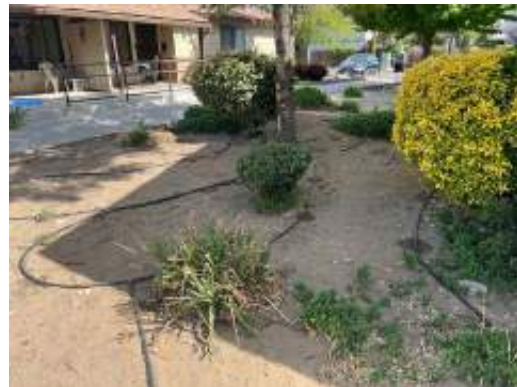
Barren Landscaping Near Building 1
(Non-Critical Repair)

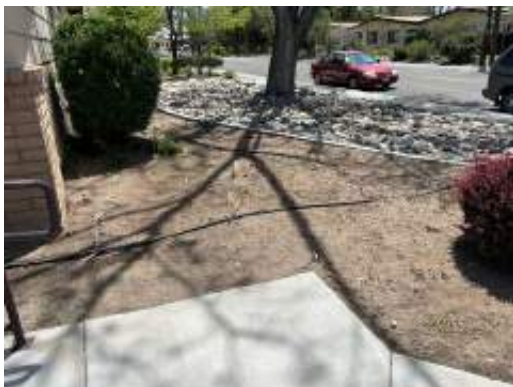
Barren Landscaping Near Building 16
(Non-Critical Repair)

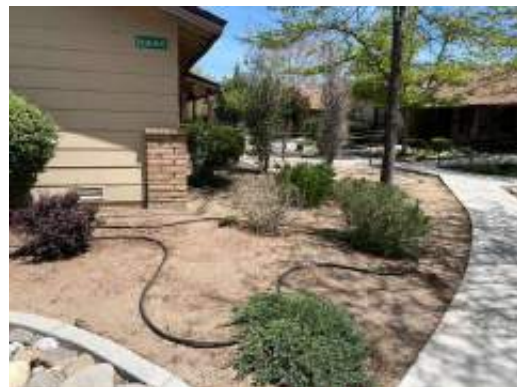
Barren Landscaping Near Building 16
(Non-Critical Repair)

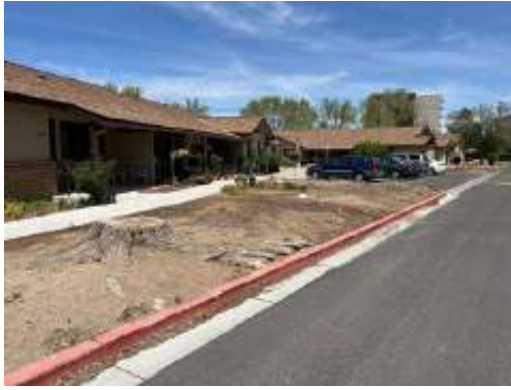
Barren Landscaping Near Building 8
(Non-Critical Repair)

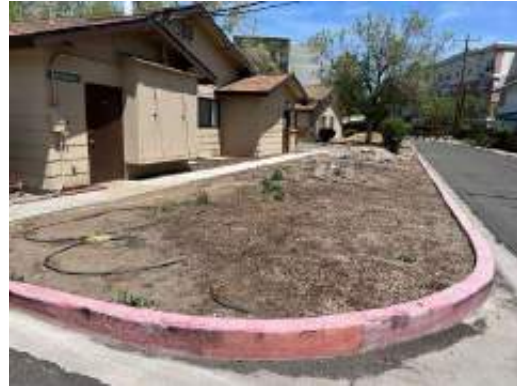
Barren Landscaping Near Building 7
(Non-Critical Repair)

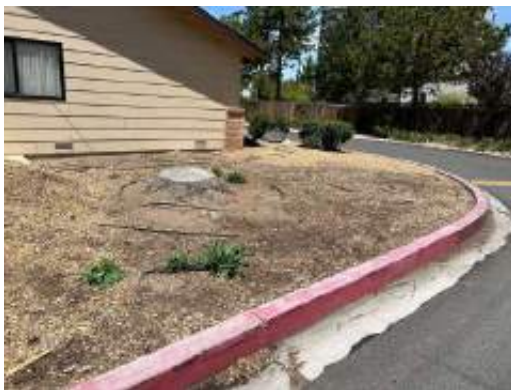
Barren Landscaping Near Building 7
(Non-Critical Repair)

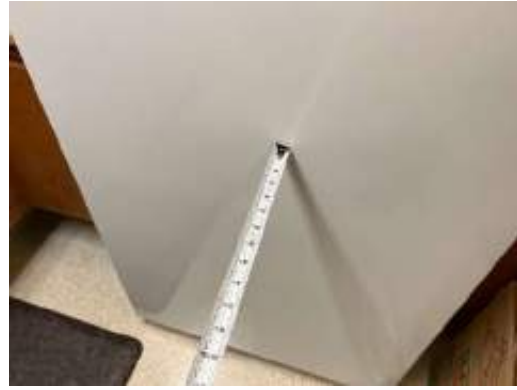
HDCP Unit 1438 Bld 2 2 Bed 1 Bath - Counter to Fridge (Repair)

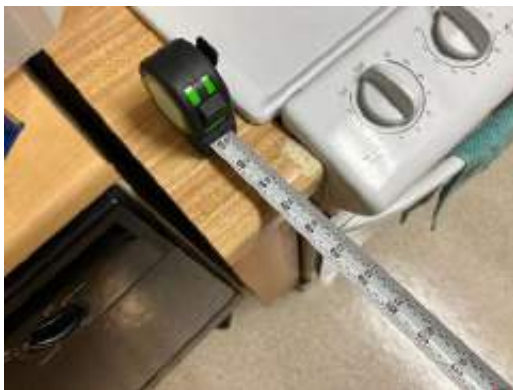
HDCP Unit 1438 Bld 2 2 Bed 1 Bath - Counter to Fridge (Repair)

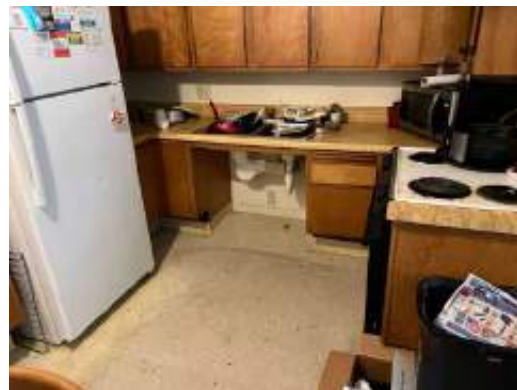
HDCP Unit 2601 Bld 9 2 Bed 1 Bath - Kitchen (Repair)

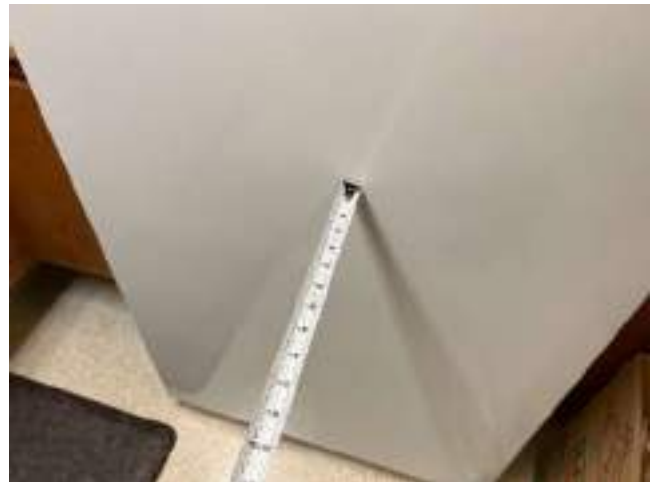
32. HDCP Unit 1438 Bld 2 2 Bed 1 Bath - Counter to Fridge (Repair)

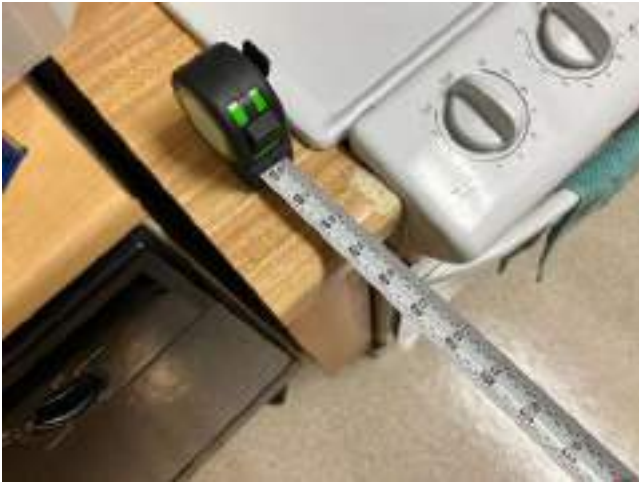
33. HDCP Unit 1438 Bld 2 2 Bed 1 Bath - Counter to Fridge (Repair)

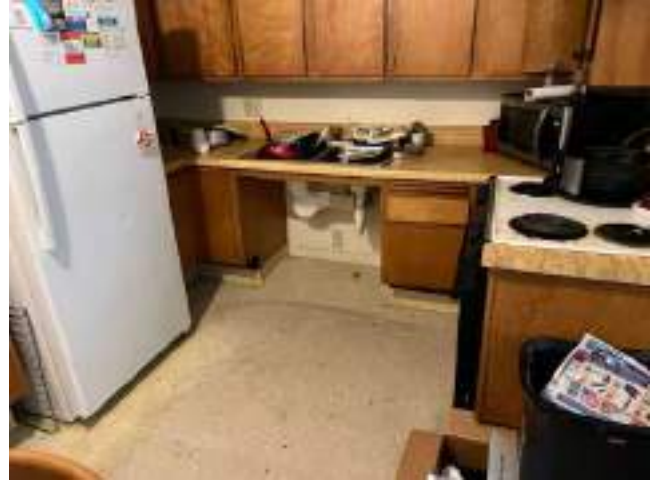
50. HDCP Unit 2601 Bld 9 2 Bed 1 Bath - Kitchen (Repair)

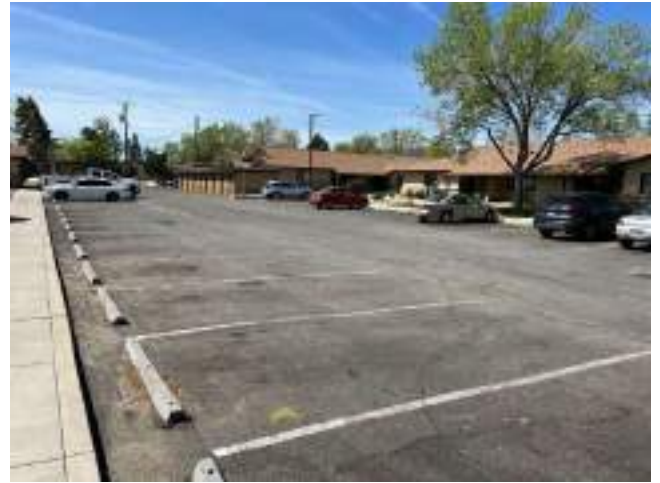
6. Parking Lot - Worn seal coat and faded striping
(Non-Critical Repair)

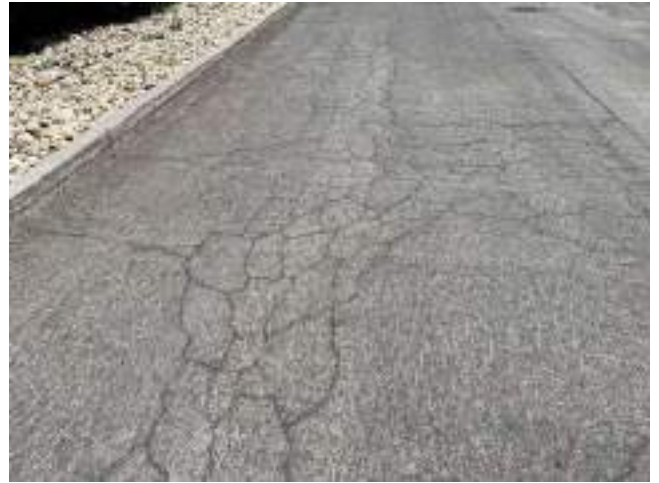
10. Asphalt Condition (Non-Critical Repair)

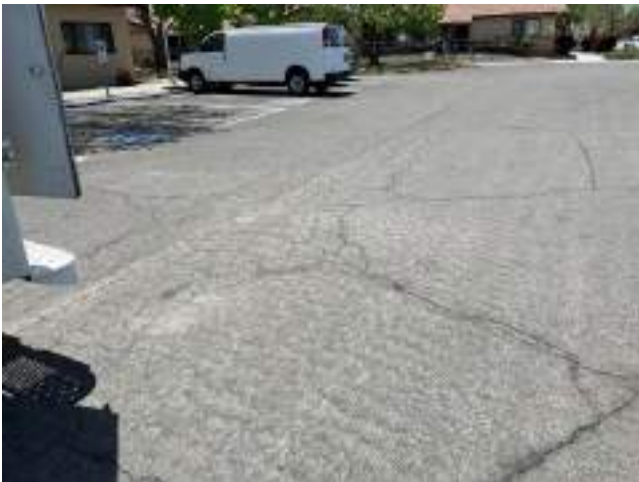
11. Asphalt Cracking at Community Center Parking Lot (Non-Critical Repair)

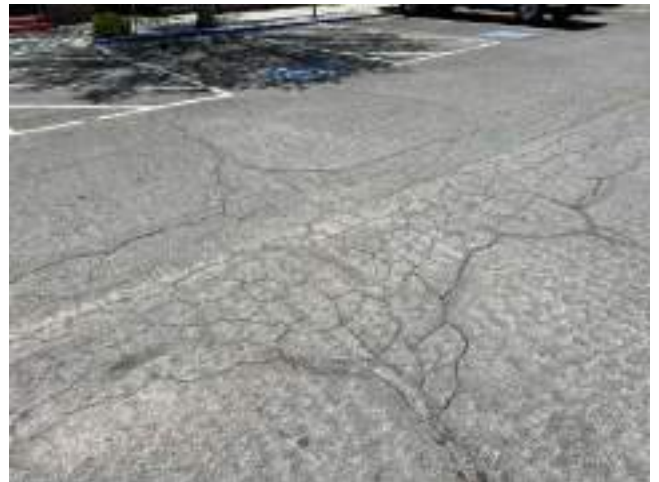
12. Asphalt Cracking at Community Center Parking Lot (Non-Critical Repair)

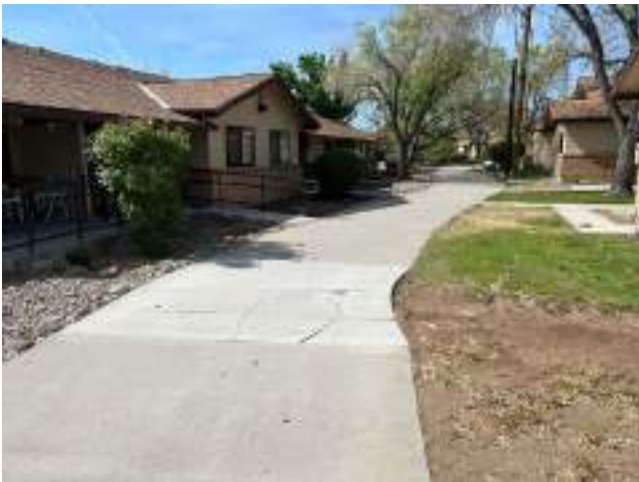
15. Cracked Sidewalk Near Building 4 (Critical Repair)

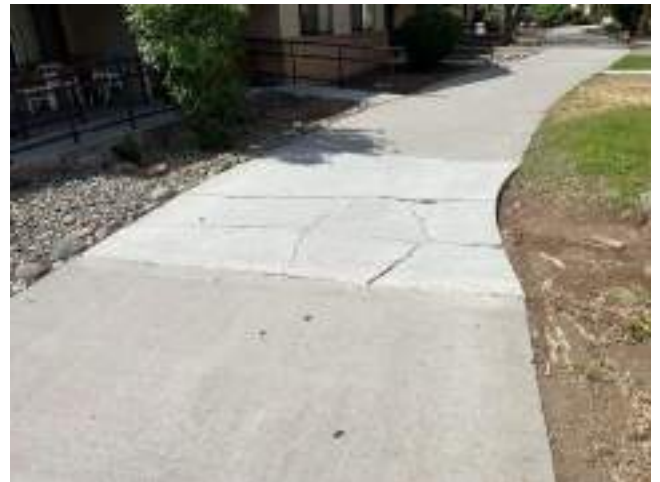
16. Cracked Sidewalk Near Building 4 (Critical Repair)

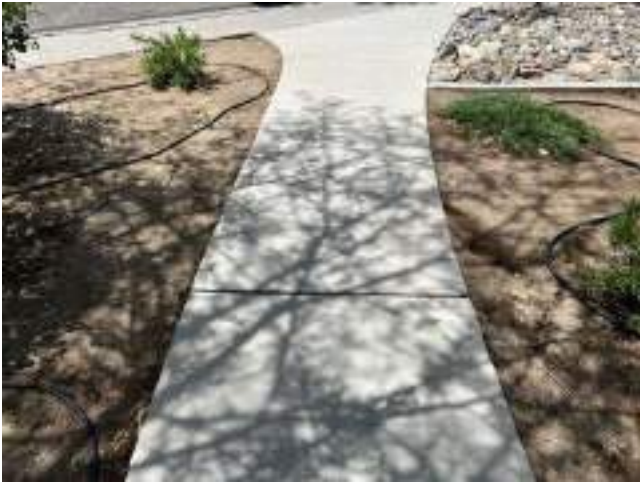
17. Trip Hazard at Sidewalk Near Building 16
(Critical Repair)

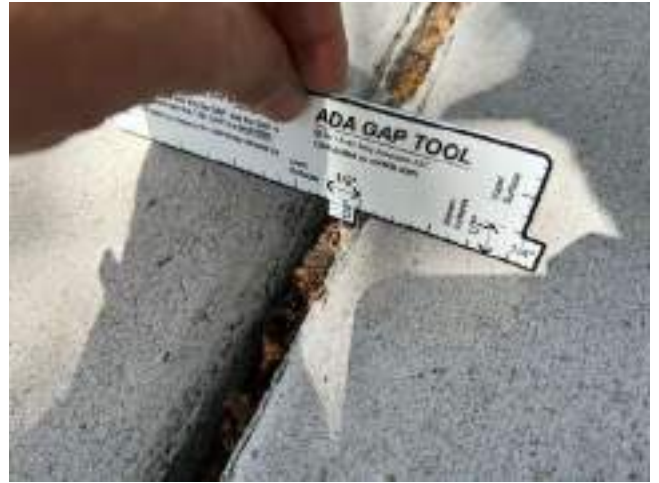
18. Trip Hazard at Sidewalk Near Building 16
(Critical Repair)

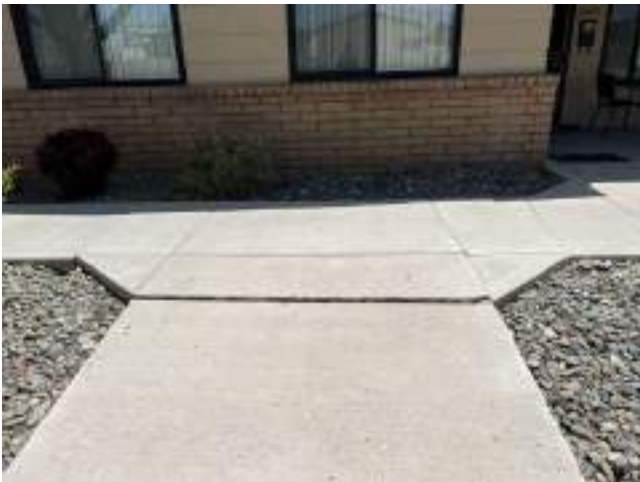
19. Trip Hazard at Sidewalk Near Building 1 (Critical Repair)

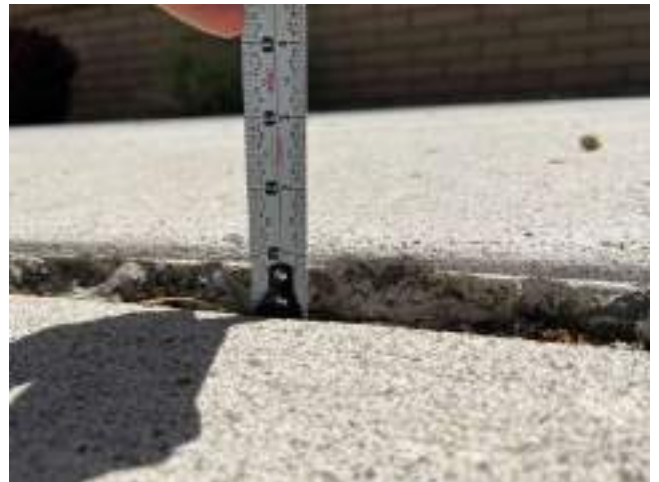
20. Trip Hazard at Sidewalk Near Building 1 (Critical Repair)

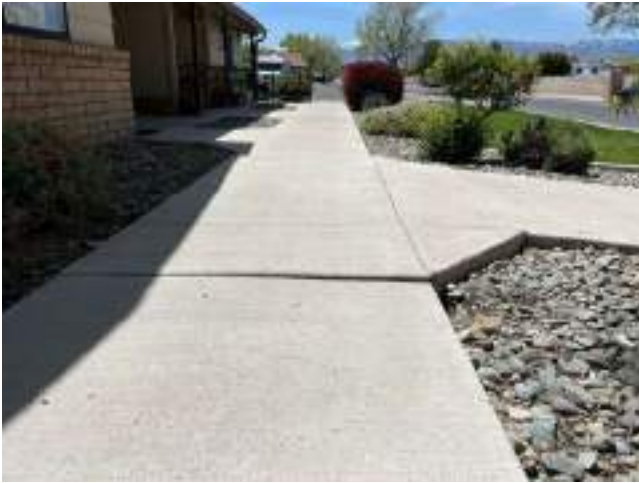
21. Trip Hazard at Sidewalk Near Building 1 (Critical Repair)

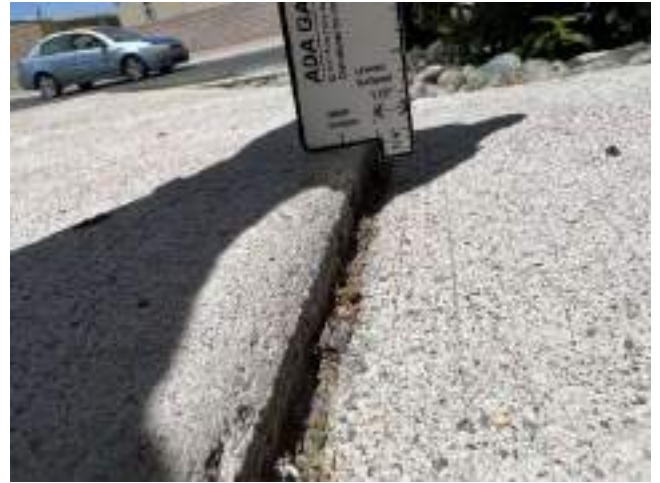
22. Trip Hazard at Sidewalk Near Building 1 (Critical Repair)

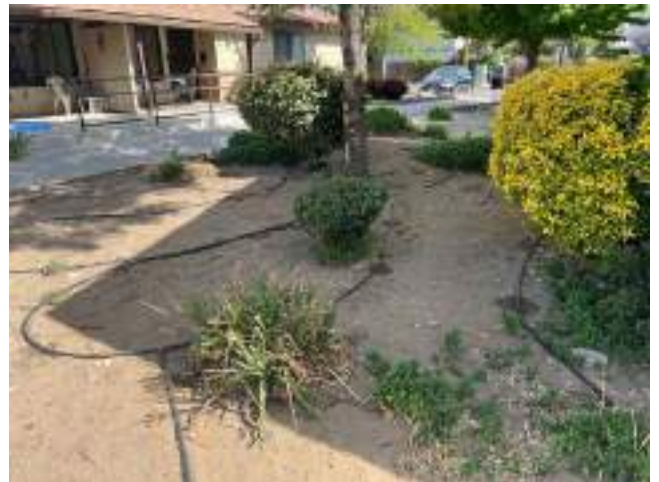
28. Barren Landscaping Near Building 1 (Non-Critical Repair)

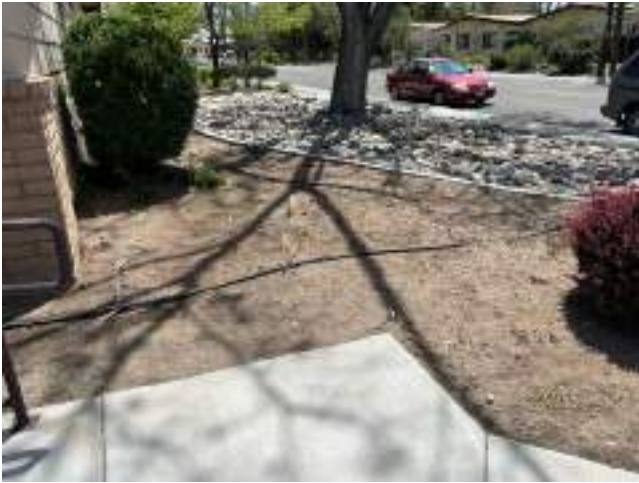
29. Barren Landscaping Near Building 16 (Non-Critical Repair)

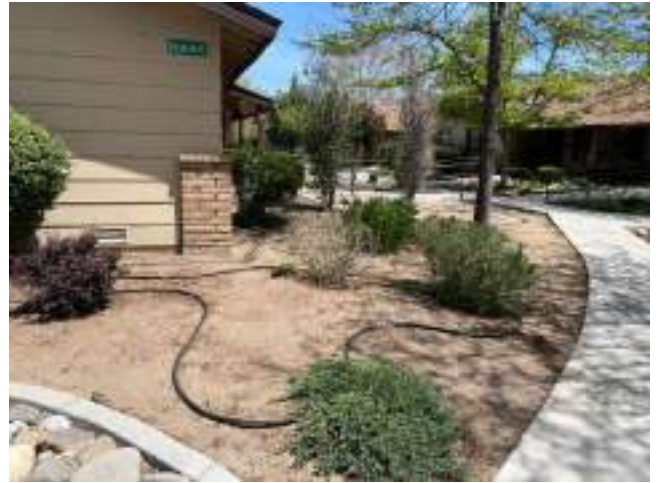
30. Barren Landscaping Near Building 16 (Non-Critical Repair)

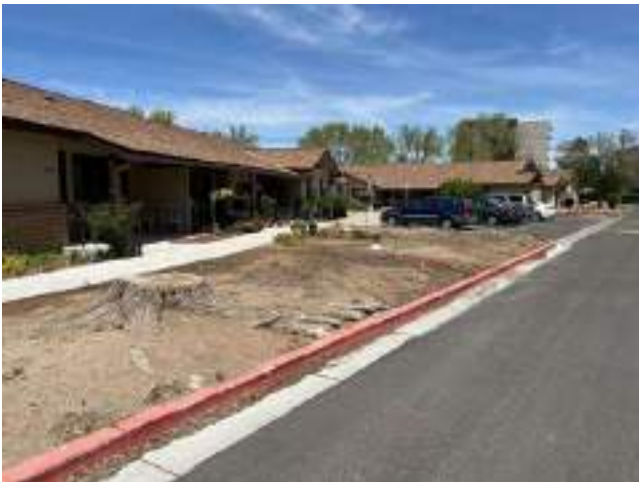
31. Barren Landscaping Near Building 8 (Non-Critical Repair)

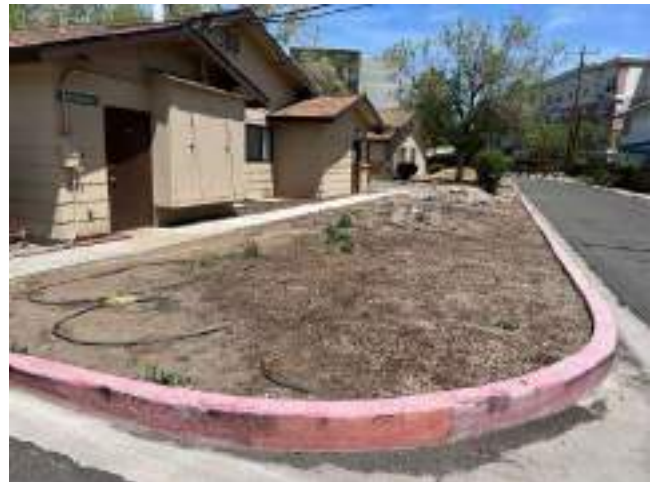
32. Barren Landscaping Near Building 7 (Non-Critical Repair)

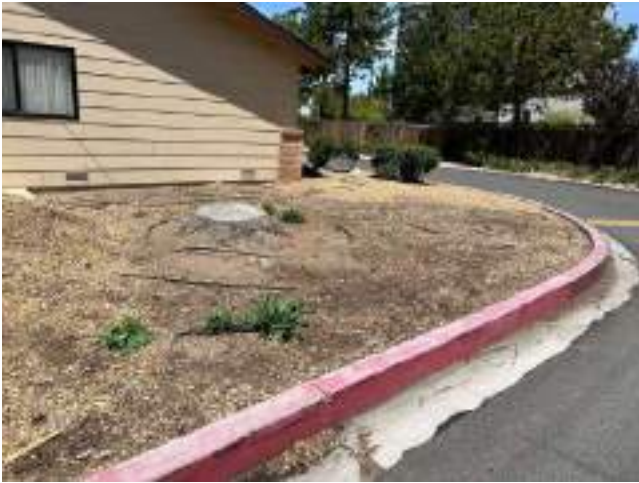
33. Barren Landscaping Near Building 7 (Non-Critical Repair)
