HUD DEMOLITION/DISPOSITION PNA

Hawk View Apartments 1548 Steelwood Lane Reno, Nevada 89512

AEI Project No. 459086

Site Inspection Date: May 18, 2022

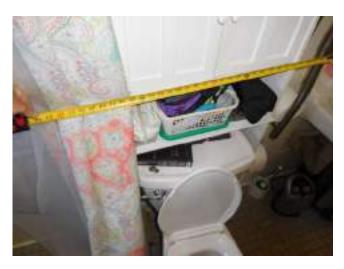
25. Bld 2541-Unit 1-2x1-UFAS -Bathroom inadequate clear space at sink (Critical Repair)

- The bathrooms in the UFAS dwelling units were observed with inadequate clear floor space at the toilet and sink. In order to comply with the UFAS, reconfiguring the restrooms in UFAS compliant dwelling units will be required.

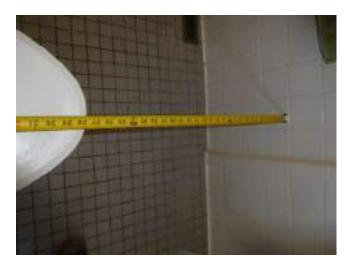
26. Bld 2541-Unit 1-2x1-UFAS -Bathroom inadequate clear space at toilet (Critical Repair)

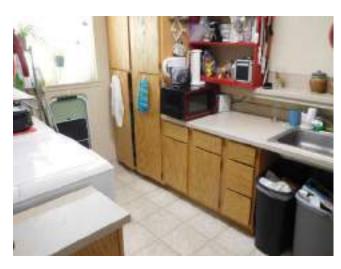
53. Bld 2541-Unit 1-2x1-UFAS -Kitchen missing cabinet and drawer handles/pulls (Critical Repair)

- The UFAS dedicated dwelling unit kitchens were observed without cabinet and drawer handles/pulls. In order to comply with Uniform Federal Accessibility Standards (UFAS), the instillation of compliant cabinet and drawer handles/pulls is required.

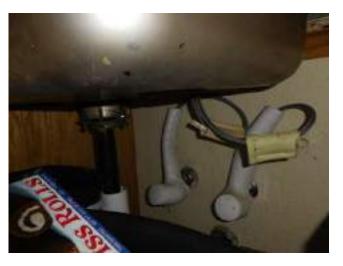
54. Bld 2541-Unit 1-2x1-UFAS -Kitchen partial scald and abrasion protection (Critical Repair)

- The roll-under kitchen and bathroom sinks located in the UFAS were observed without or with partial scald and abrasion protection. The installation of full coverage scald and abrasion protection is required.

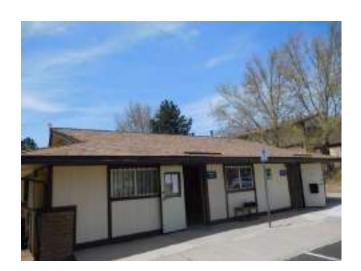
24. Leasing Office front with ADA parking space, non-van accessible (Critical Repair)

- The Leasing Office was observed with a van complaint parking space which was missing the van specific signage. AEI recommends the instillation of van specific signage at one of the two Leasing Office accessible parking spaces.

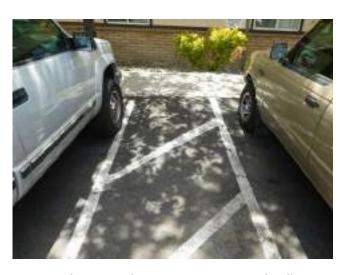
74. Typical ADA parking space at UFAS dwelling unit excessive slope and cross slope at access ramp (Critical Repair)

- Each of the UFAS qualifying dwelling units is equipped with an accessible parking space. The spaces were observed with a non-compliant access ramp to the adjacent flatwork site pathway to the dwelling unit. AEI recommends the installation of a compliant curb cut at each accessible space provided at each UFAS qualifying dwelling unit.

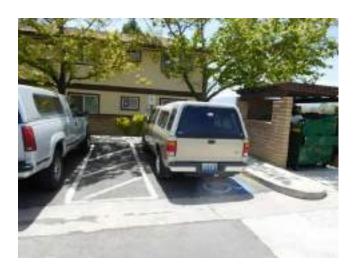
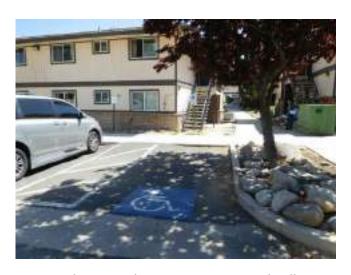
75. Typical ADA parking space at UFAS dwelling unit 76. Typical ADA parking space at UFAS dwelling unit excessive slope and cross slope at access ramp (Critical Repair)

excessive slope and cross slope at access ramp (Critical Repair)

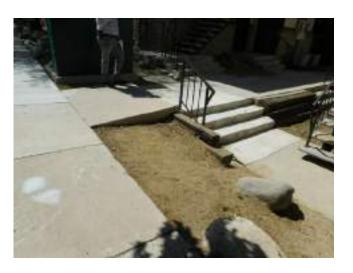
82. Site stairway and sectional uplift trip hazard between 1512 and 1504 Buildings, single hand railing at 3 site stairways (Critical Repair)

- Three (3) site stairways between 1512 and 1504 Buildings were observed with a single hand railing. Complaint dual hand railings should be provided on both sides of onsite stairways.

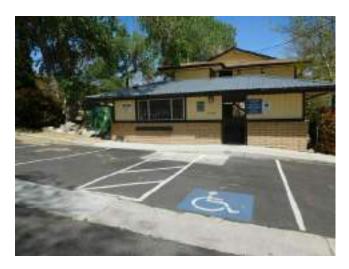
87. Laundry room with non-compliant access pathway from accessible space (Critical Repair)

- The laundry building is equipped with an accessible parking space which was observed to have a curb cut but with a non-compliant pathway from the space to the curb cut. AEI recommends moving the accessible space and signage, so the pathway lines up with the provided curb cut.

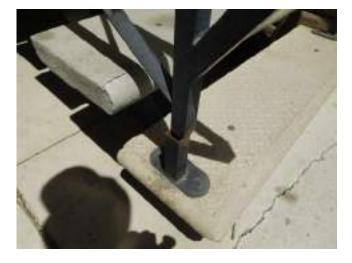
100. Upper floor unit access stairway at 1516 building damaged hand railing (Critical Repair)

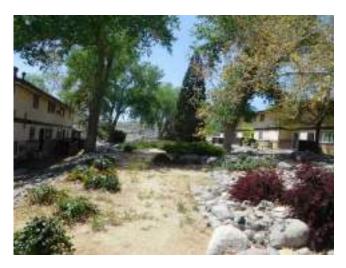
116. Area of bare ground between 2539 and 1540 buildings (Non-Critical Repair)

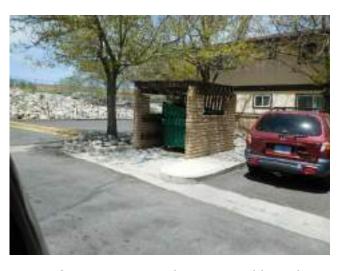
122. Refuse container with no accessible pathway (Critical Repair)

- The refuse enclosures were observed to be without a compliant accessible pathway from the UFAS dwelling units. To comply with UFAS AEI recommends the installation of a complaint pathway from the UFAS dwelling units to refuse enclosures.

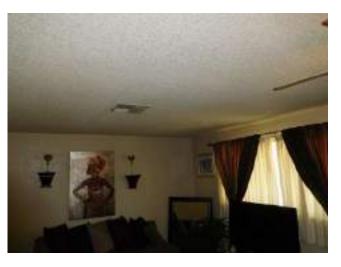
141. Typical drywall damage from building settling

- The unit gypsum board (drywall) was observed to be in fair to poor condition. The drywall as observed areas of cracking and separating due to foundation issues. Replacement of the plumbing pipes warranted removal of select areas (approximately 90% in total) of drywall is needed.

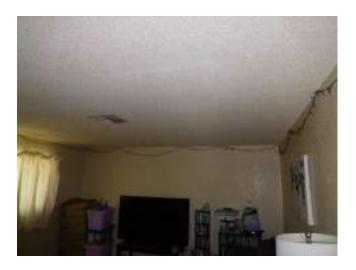
142. Typical drywall damage from building settling

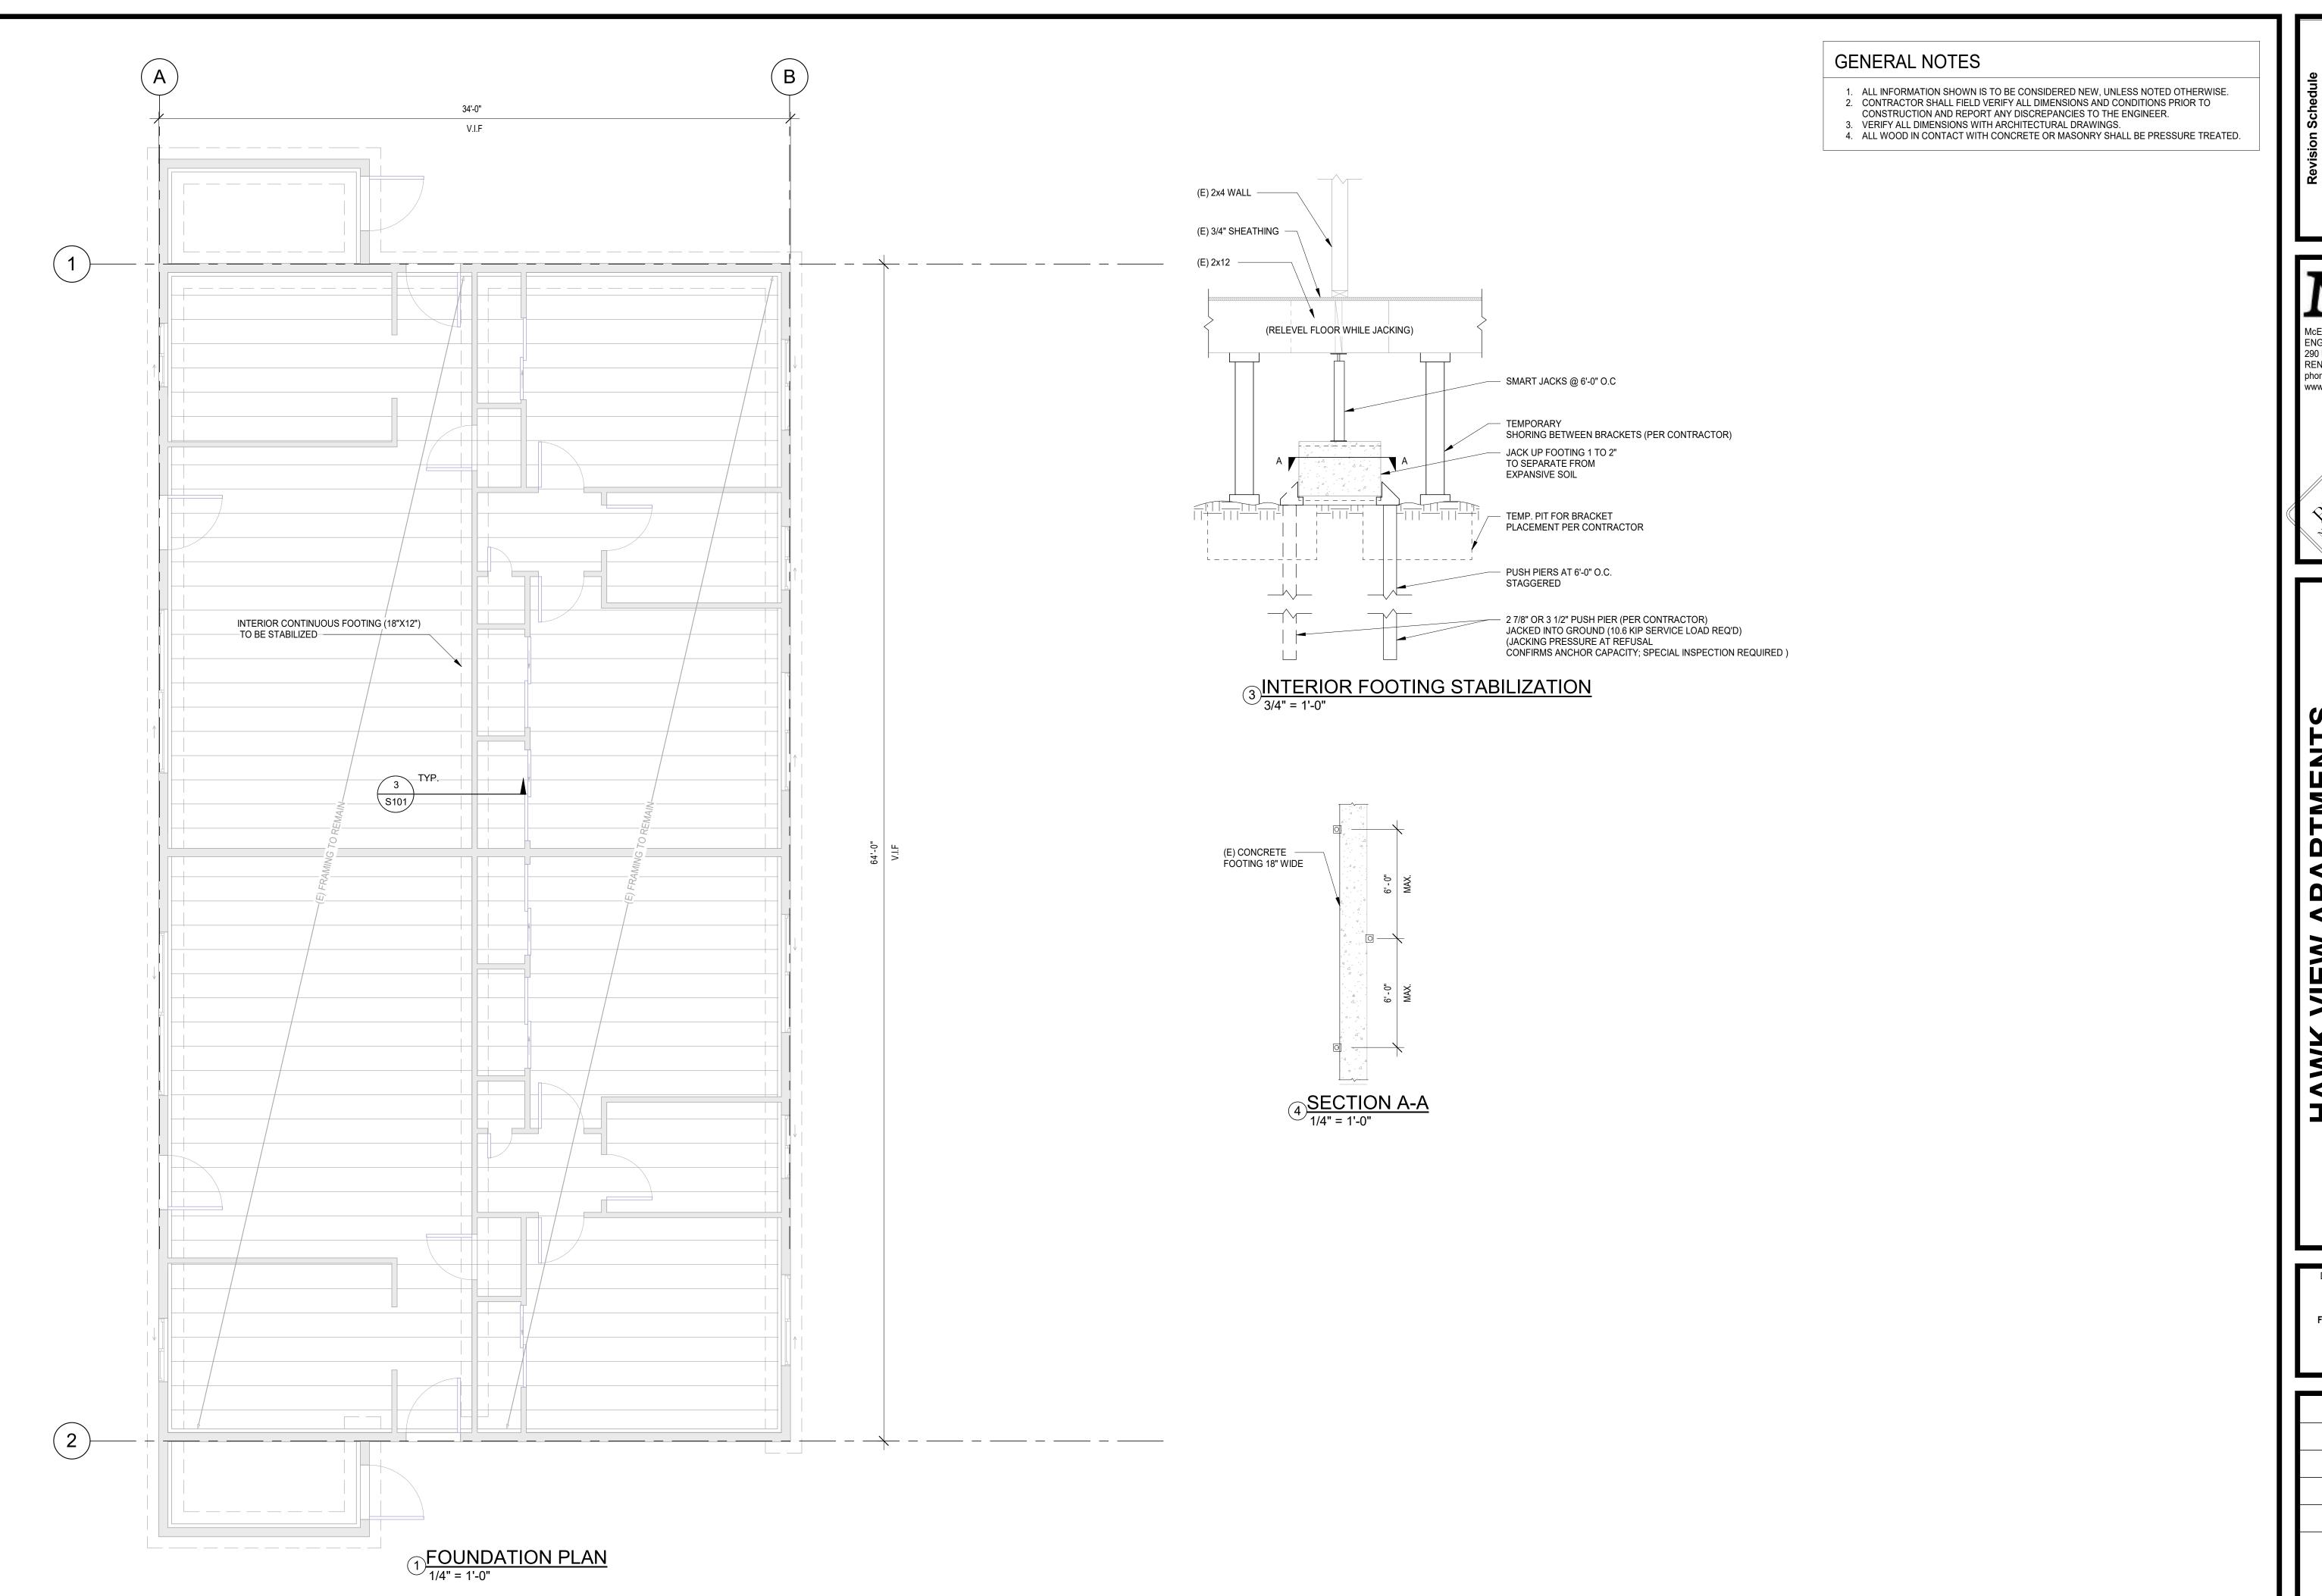
S002

FOUNDATION PLAN/DETAILS
