HUD CAPITAL NEEDS ASSESSMENT

Silverada Manor
1402 Silverada Boulevard
Reno, Nevada 89512

AEI Project No. 459084
Site Inspection Date: May 18, 2022

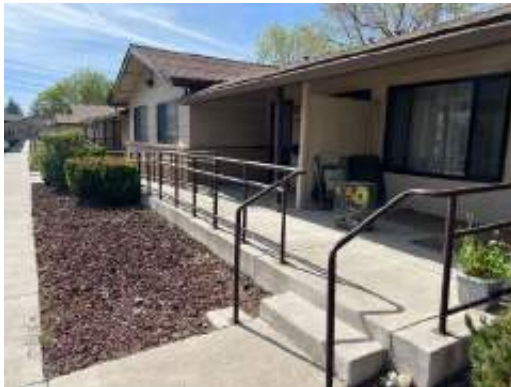
Concrete Ramp and Stairs at Apartment Entry

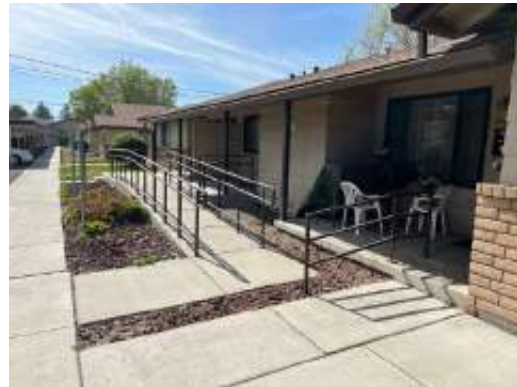
Ramp at Unit Entry

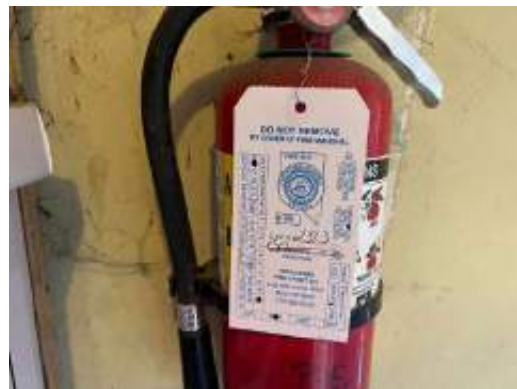
Expired Extinguisher Inspection Tag

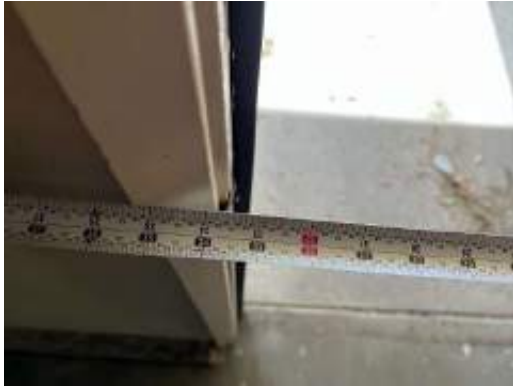
Laundry Room Door Width

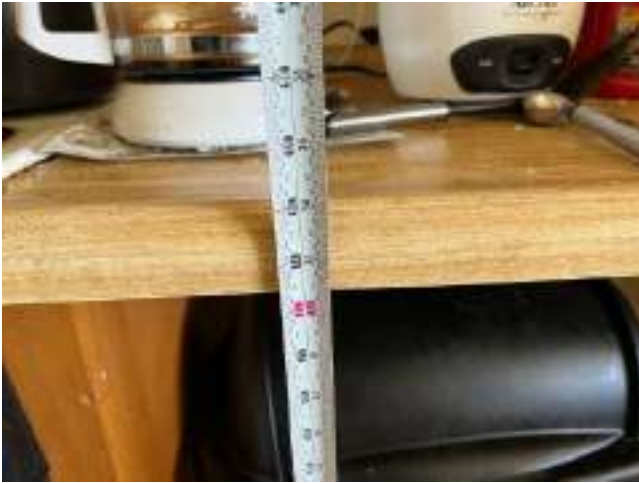
5. HDCP Unit 2493 Bld 15 Studio - Kitchen Counter Height

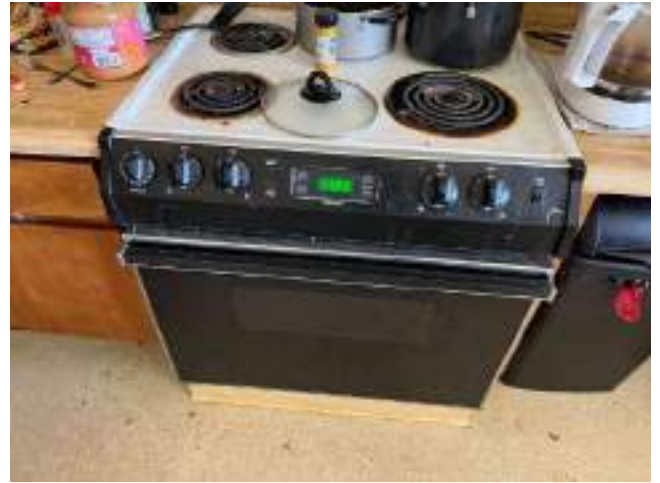
6. HDCP Unit 2493 Bld 15 Studio - Range with Front Controls

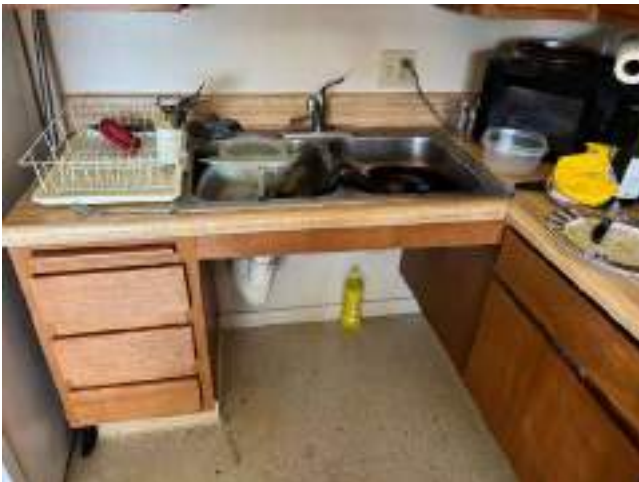
7. HDCP Unit 2493 Bld 15 Studio - Kitchen Sink

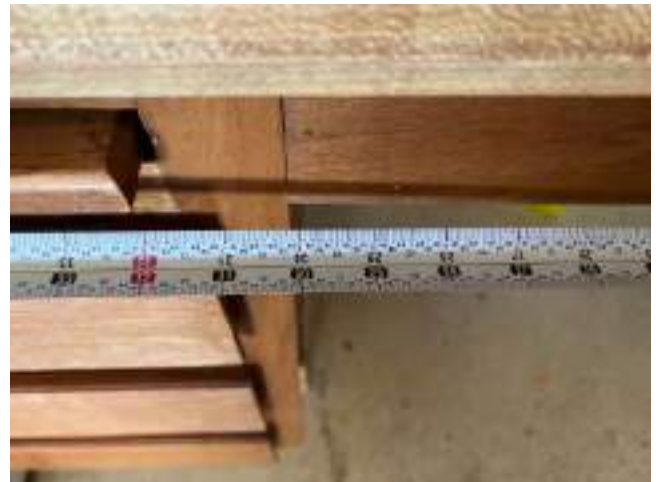
8. HDCP Unit 2493 Bld 15 Studio - Sink Width

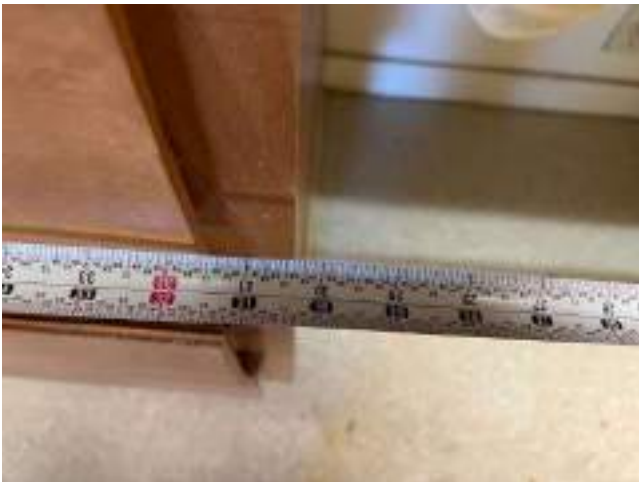
19. HDCP Unit 2605 Bld 9 1 Bed 1 Bath - Sink Width

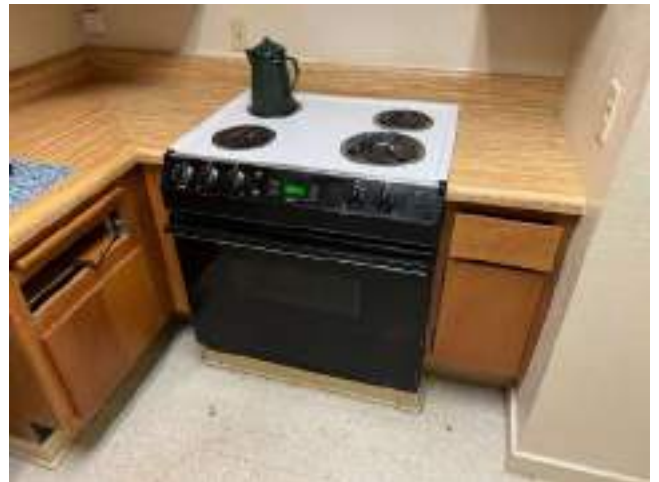
20. HDCP Unit 2605 Bld 9 1 Bed 1 Bath - Range with Front Controls
