HUD CAPITAL NEEDS ASSESSMENT

Silverada Manor
1402 Silverada Boulevard
Reno, Nevada 89512

AEI Project No. 459084
Site Inspection Date: May 18, 2022

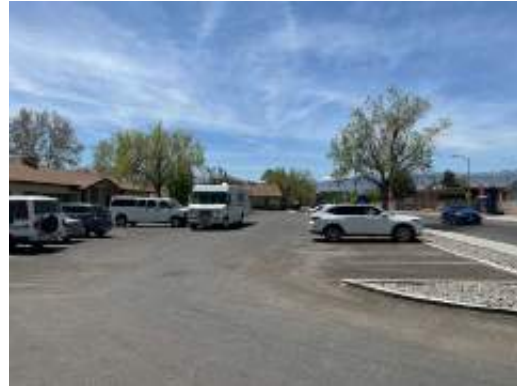
Parking Lot at Community Center

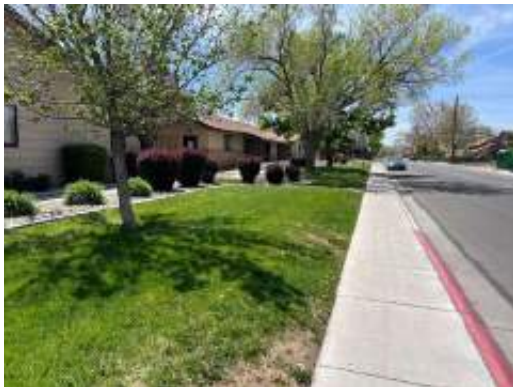
Landscaping

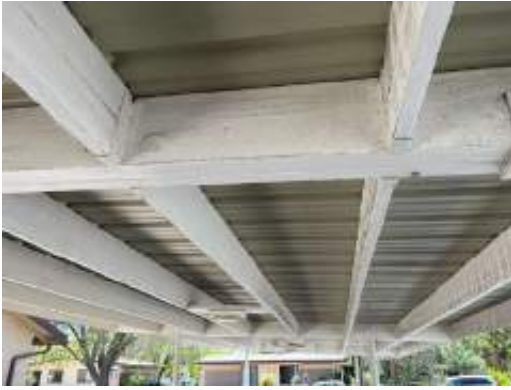
Carport Framing

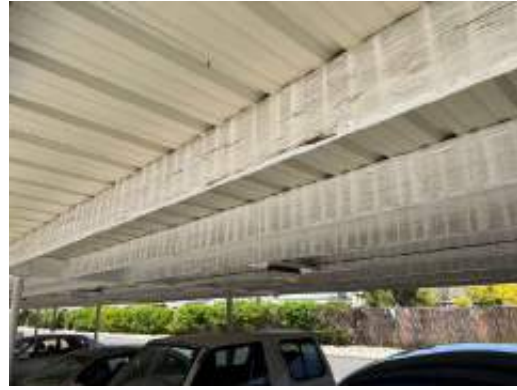
Carport Framing

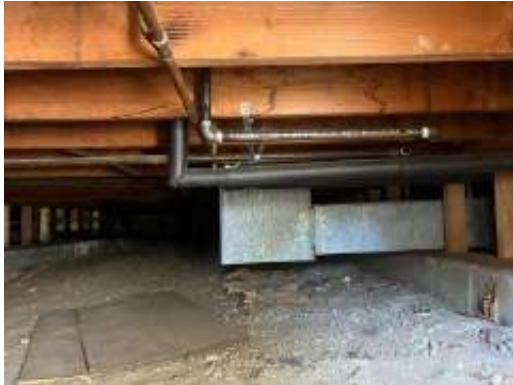
Crawl Space

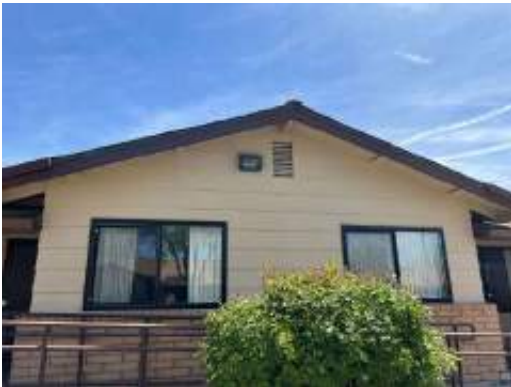
Attic Vent

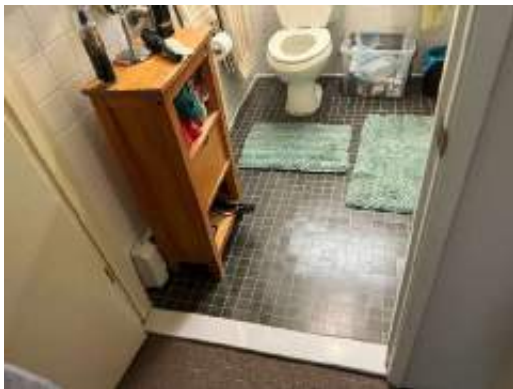
Ceramic Tile at Mobility Unit

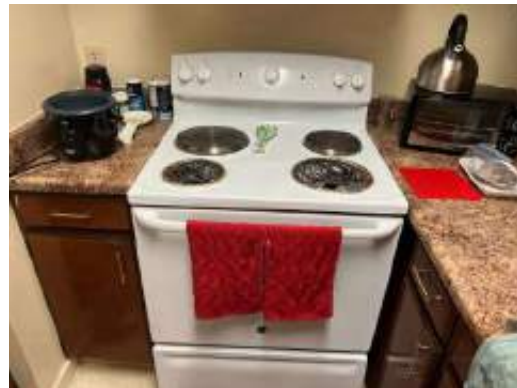
Range (Newer)

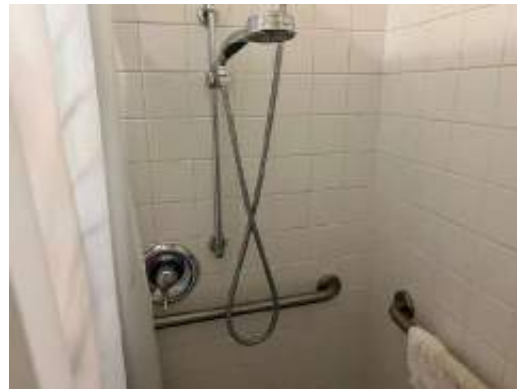
Ceramic Tile Shower Surround at Mobility Unit

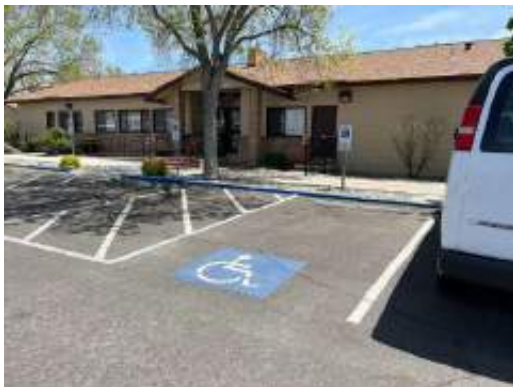
ADA Stalls at Community Center - Office

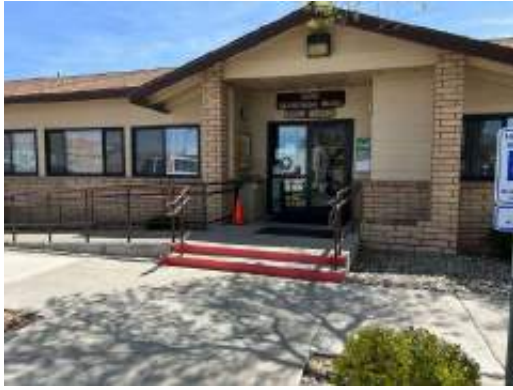
Entry Stairs at Community Center - Office

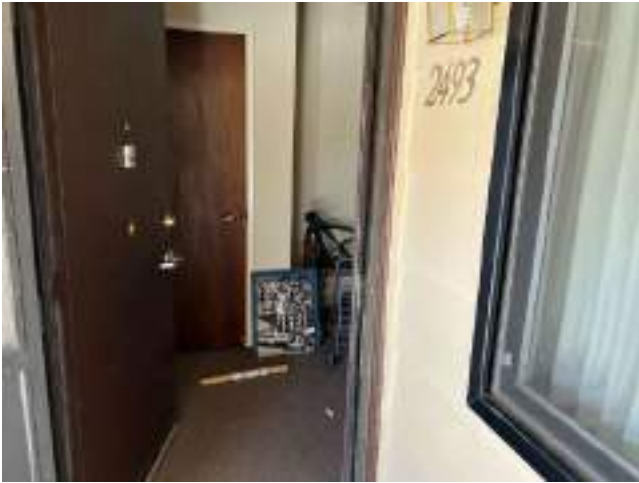
1. HDCP Unit 2493 Bld 15 Studio - Entry

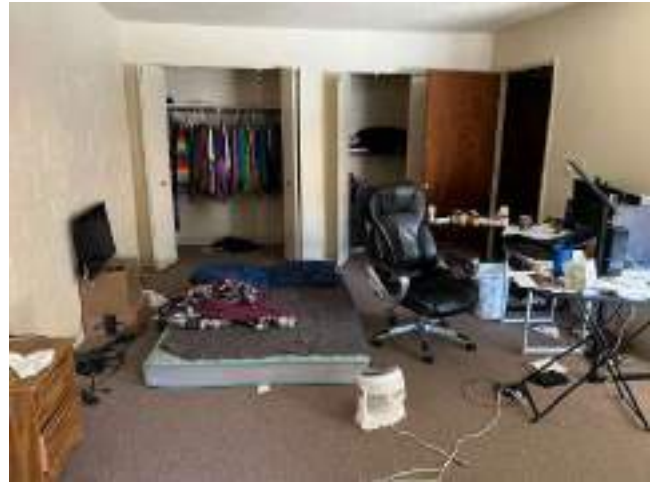
2. HDCP Unit 2493 Bld 15 Studio - Living Area

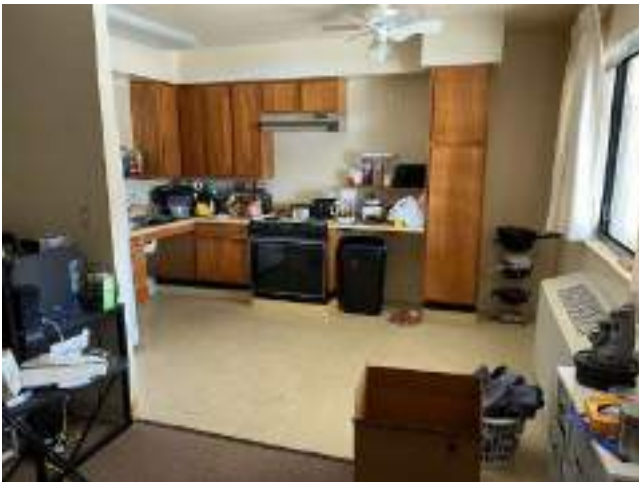
3. HDCP Unit 2493 Bld 15 Studio - Kitchen

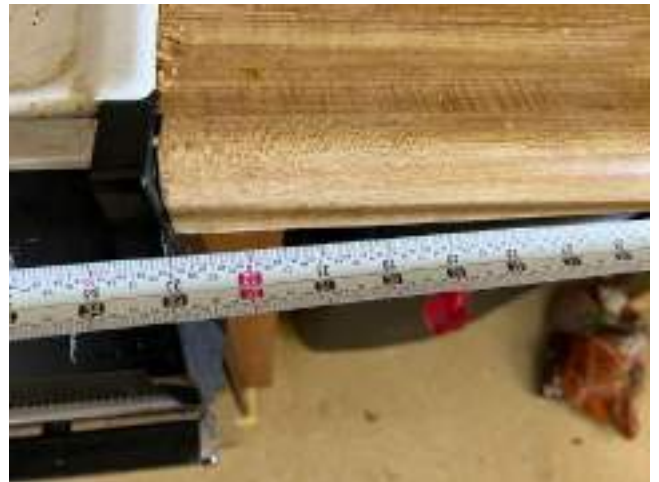
4. HDCP Unit 2493 Bld 15 Studio - Workspace Width

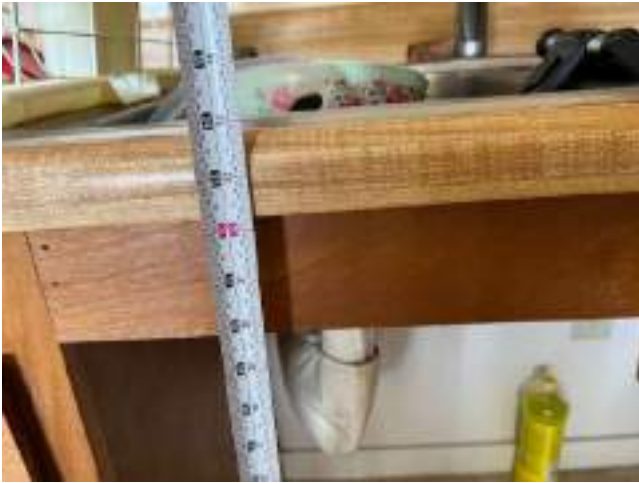
9. HDCP Unit 2493 Bld 15 Studio - Sink Height

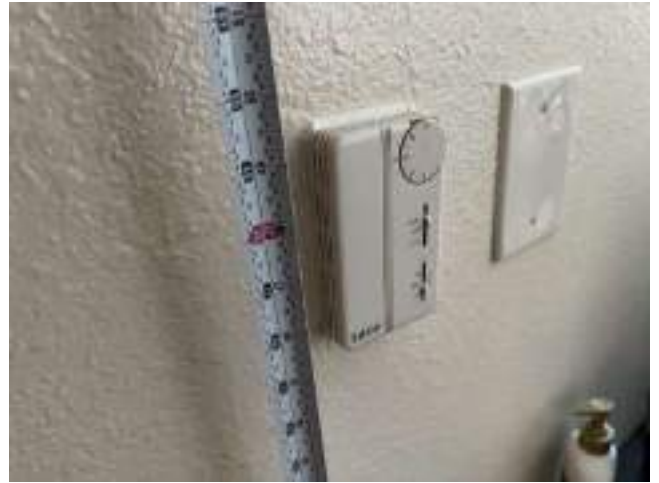
10. HDCP Unit 2493 Bld 15 Studio - Thermostat Height

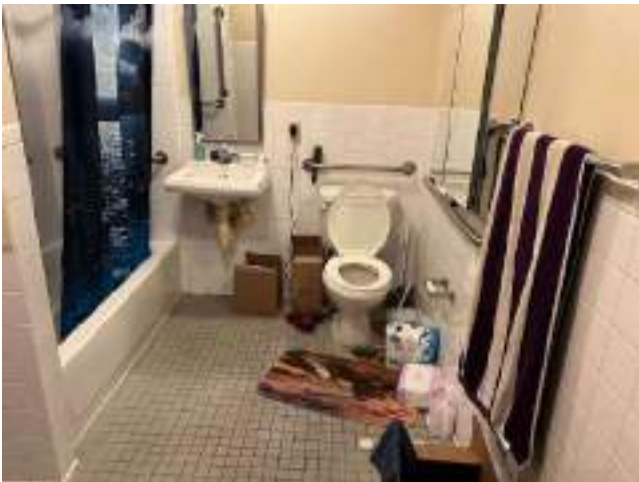
11. HDCP Unit 2493 Bld 15 Studio - Bathroom

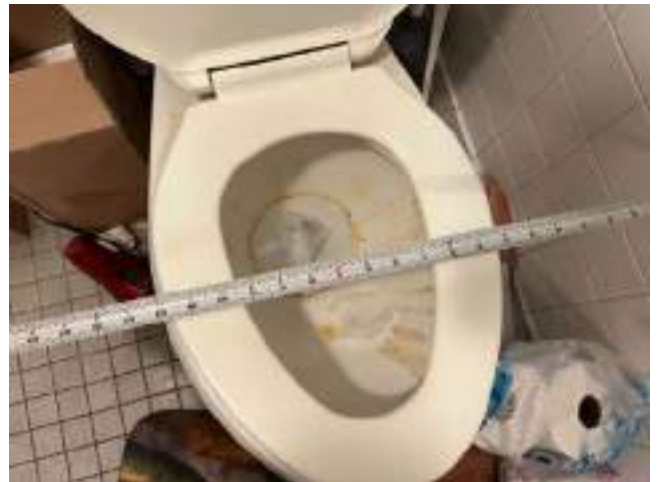
12. HDCP Unit 2493 Bld 15 Studio - Toilet Center

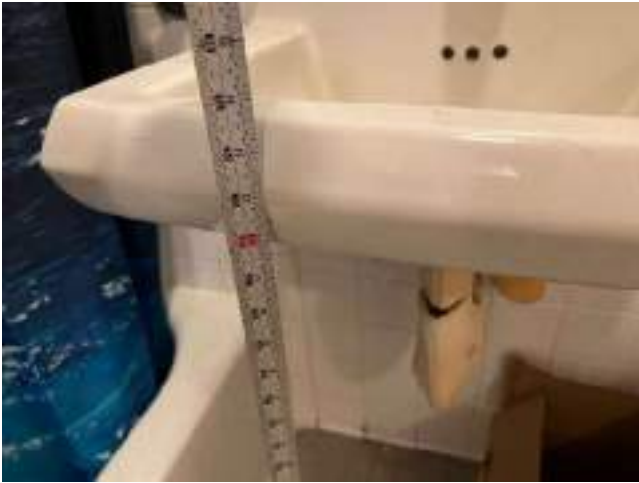
13. HDCP Unit 2493 Bld 15 Studio - Vanity Height

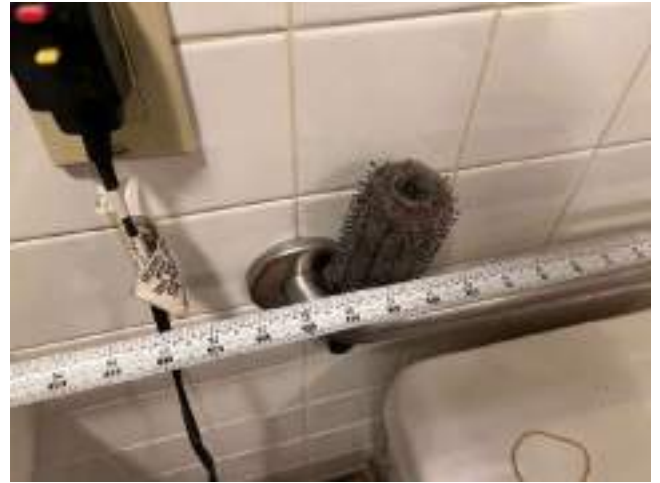
14. HDCP Unit 2493 Bld 15 Studio - Rear Grab Bar Width

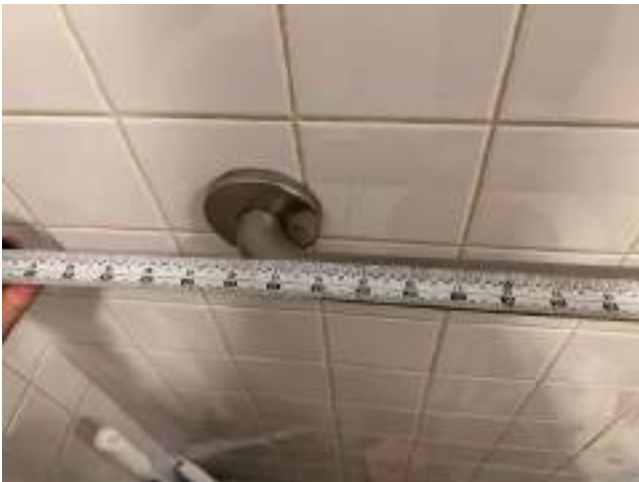
15. HDCP Unit 2493 Bld 15 Studio - Side Grab Bar Width

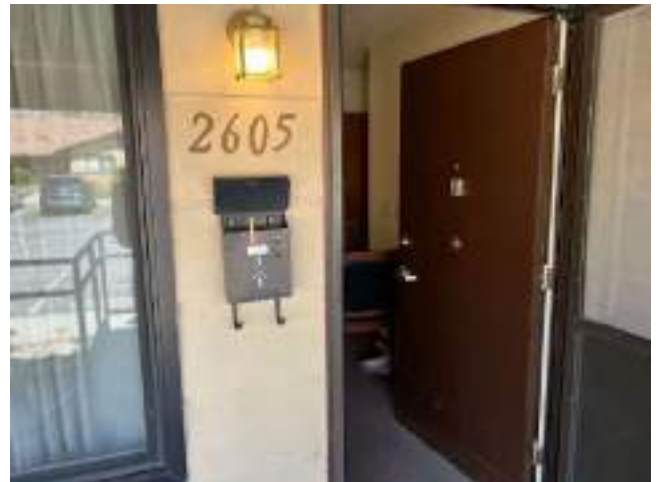
16. HDCP Unit 2605 Bld 9 1 Bed 1 Bath - Entry

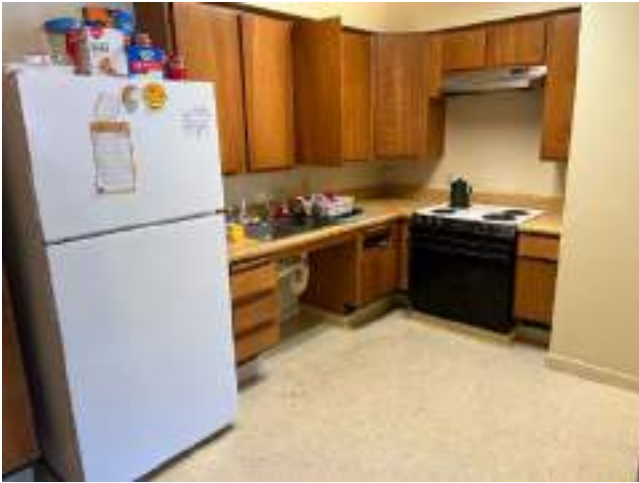
17. HDCP Unit 2605 Bld 9 1 Bed 1 Bath - Kitchen

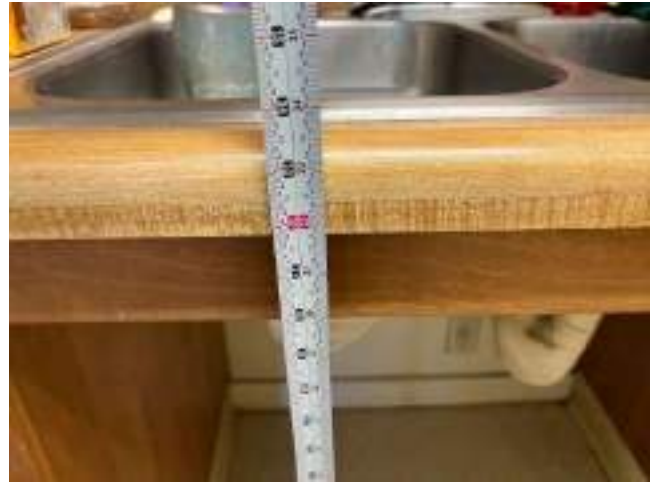
18. HDCP Unit 2605 Bld 9 1 Bed 1 Bath - Counter Height

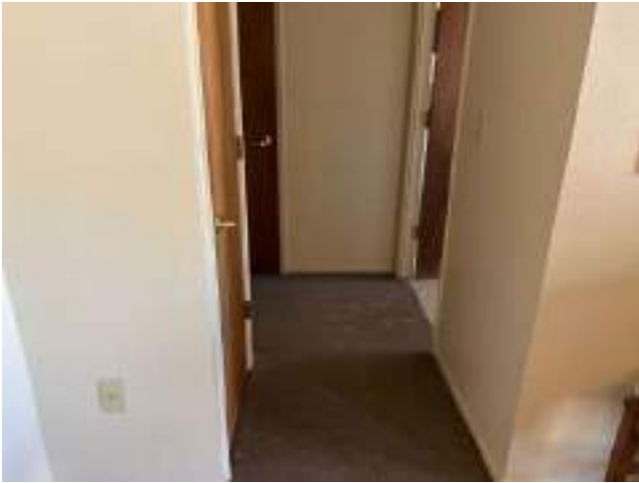
21. HDCP Unit 2605 Bld 9 1 Bed 1 Bath - Hallway

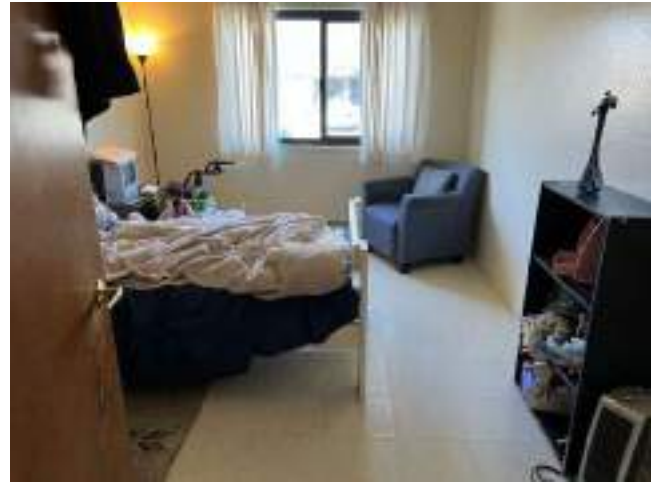
22. HDCP Unit 2605 Bld 9 1 Bed 1 Bath - Bedroom

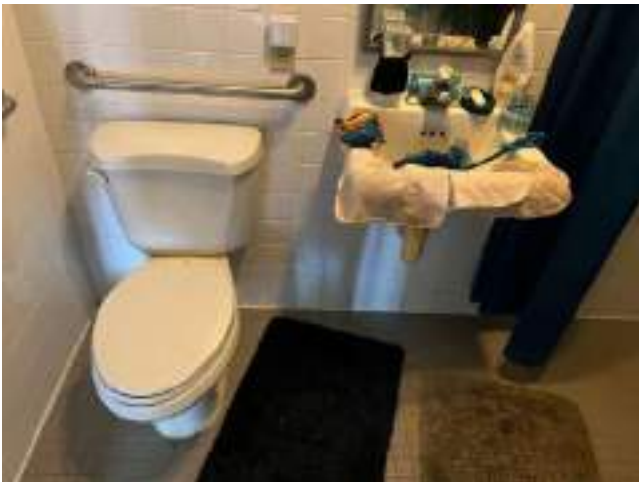
23. HDCP Unit 2605 Bld 9 1 Bed 1 Bath - Bathroom

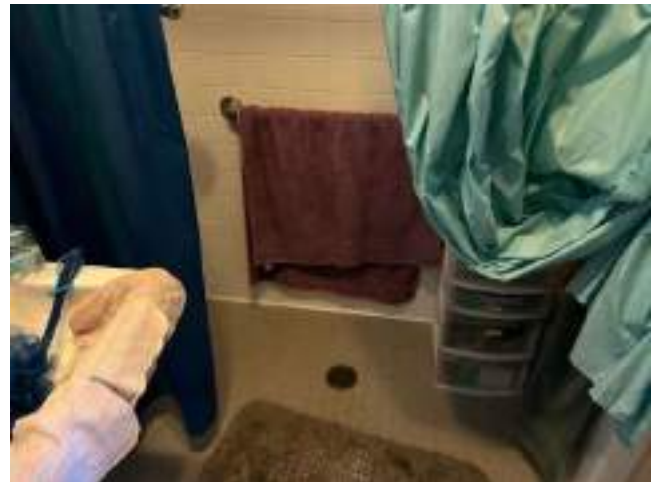
24. HDCP Unit 2605 Bld 9 1 Bed 1 Bath - Roll In Shower

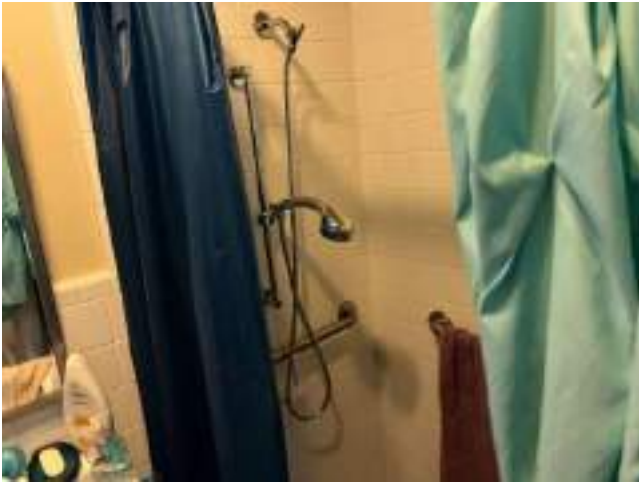
25. HDCP Unit 2605 Bld 9 1 Bed 1 Bath - Shower

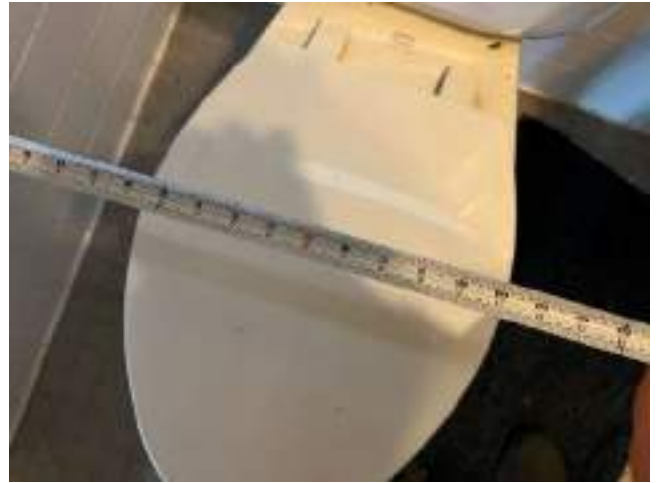
26. HDCP Unit 2605 Bld 9 1 Bed 1 Bath - Toilet Center

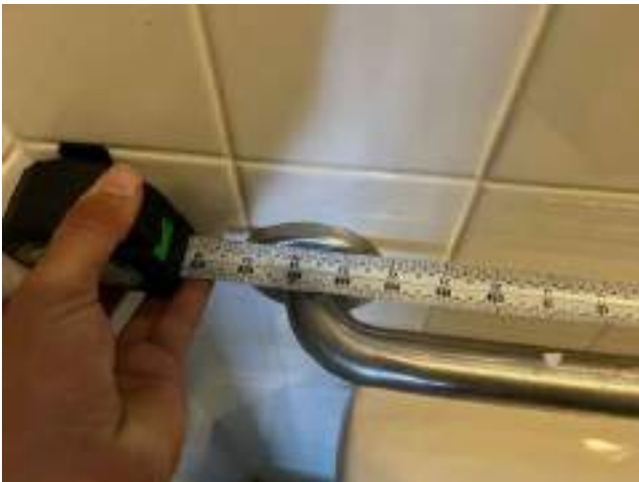
27. HDCP Unit 2605 Bld 9 1 Bed 1 Bath - Rear Grab Bar Width

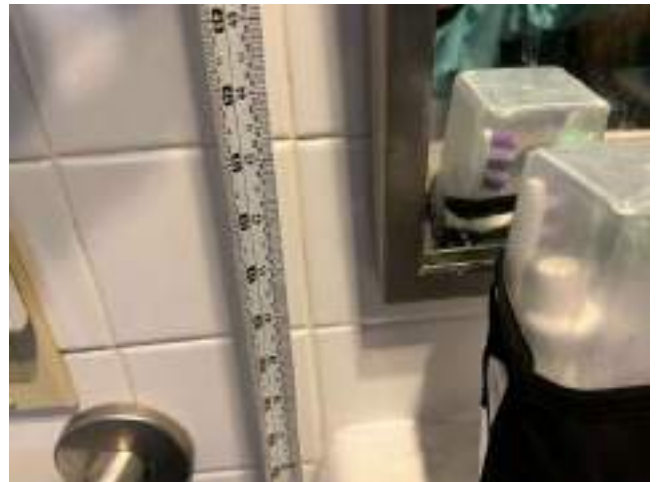
28. HDCP Unit 2605 Bld 9 1 Bed 1 Bath - Mirror Height

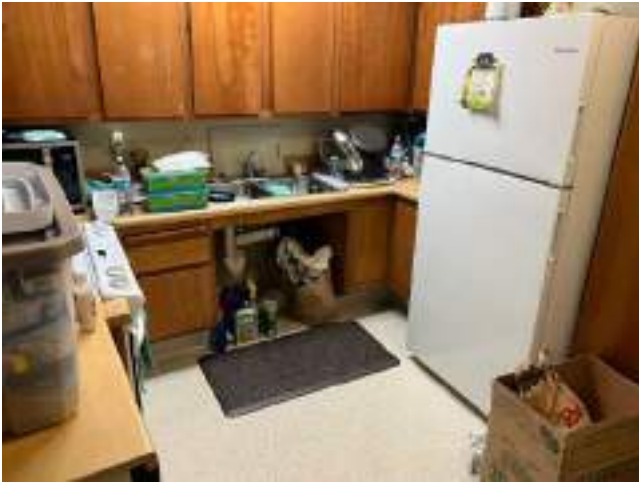
29. HDCP Unit 1438 Bld 2 2 Bed 1 Bath - Kitchen

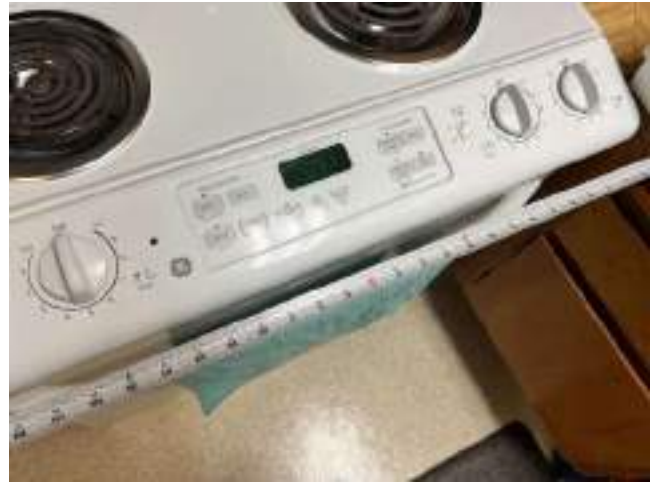
30. HDCP Unit 1438 Bld 2 2 Bed 1 Bath - Range Center

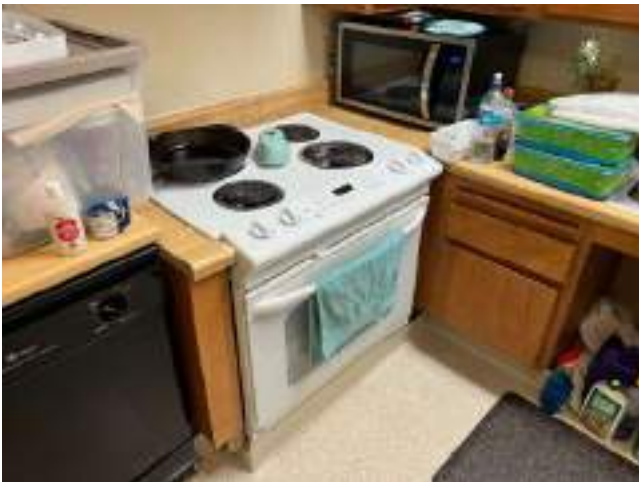
31. HDCP Unit 1438 Bld 2 2 Bed 1 Bath - Range with Front Controls

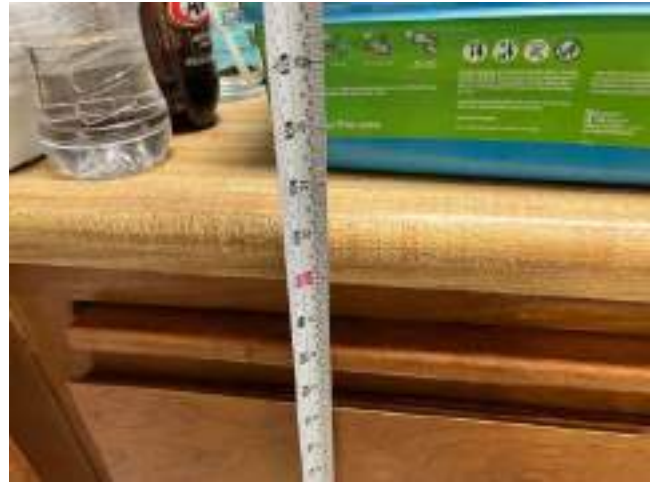
34. HDCP Unit 1438 Bld 2 2 Bed 1 Bath - Counter Height

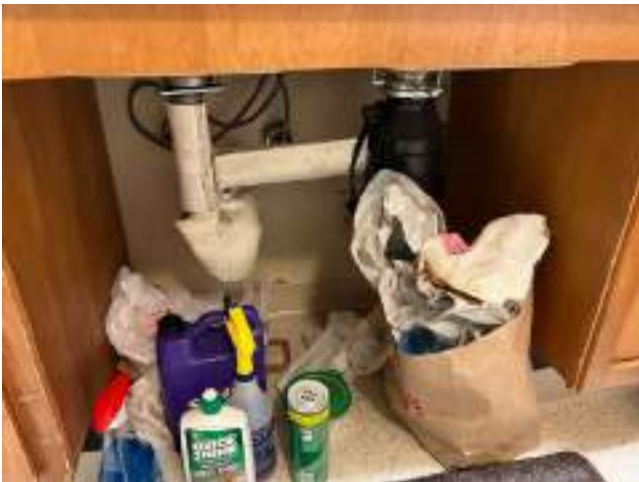
35. HDCP Unit 1438 Bld 2 2 Bed 1 Bath - Clear Knee Space Under Sink

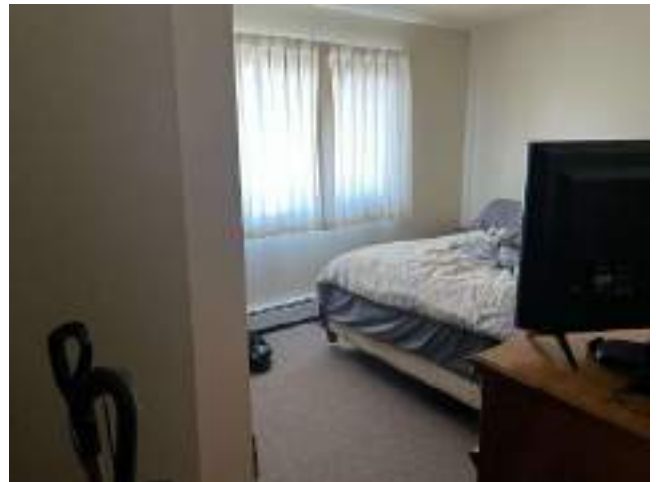
36. HDCP Unit 1438 Bld 2 2 Bed 1 Bath - Bedroom

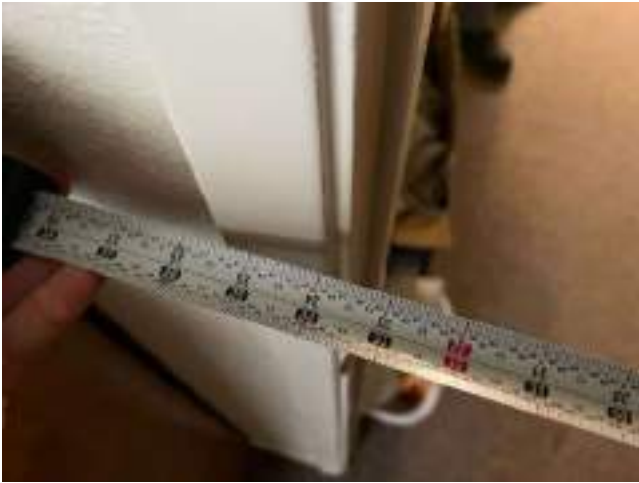
37. HDCP Unit 1438 Bld 2 2 Bed 1 Bath - Bedroom Door Width

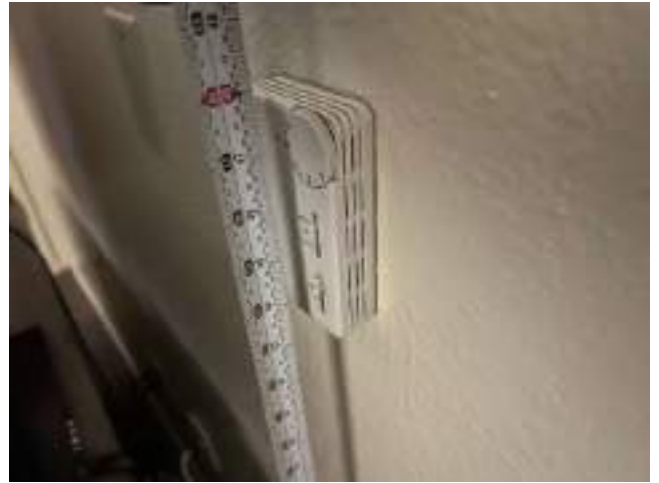
38. HDCP Unit 1438 Bld 2 2 Bed 1 Bath - Thermostat Height

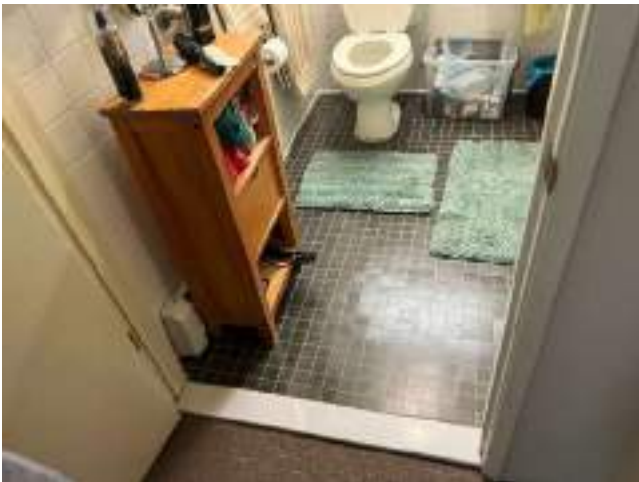
39. HDCP Unit 1438 Bld 2 2 Bed 1 Bath - Bathroom

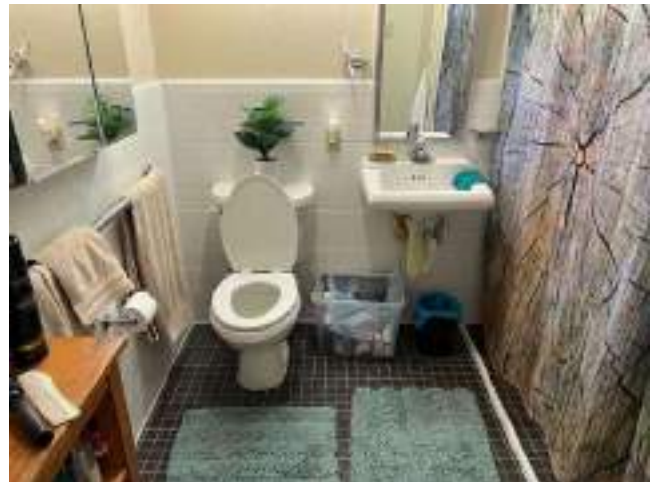
40. HDCP Unit 1438 Bld 2 2 Bed 1 Bath - Bathroom

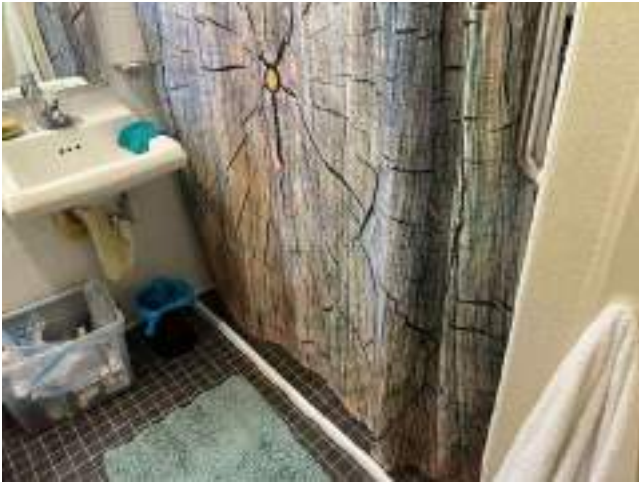
41. HDCP Unit 1438 Bld 2 2 Bed 1 Bath - Roll In Shower

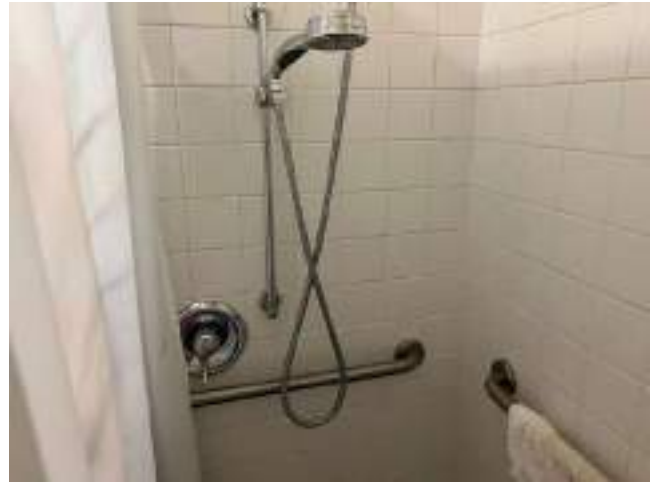
42. HDCP Unit 1438 Bld 2 2 Bed 1 Bath - Shower

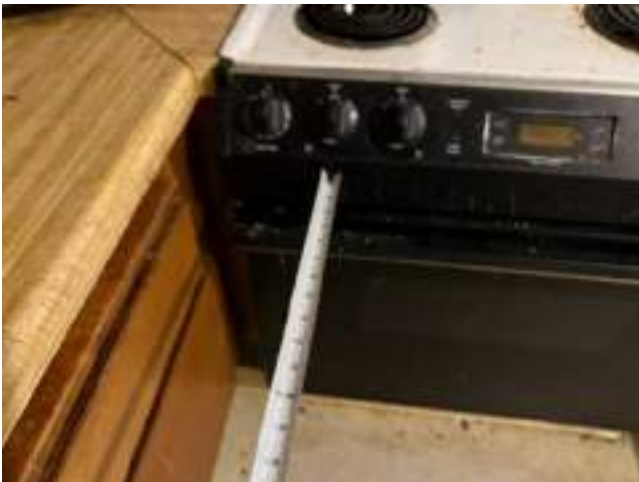
50. HDCP Unit 2601 Bld 9 2 Bed 1 Bath - Kitchen (Repair)

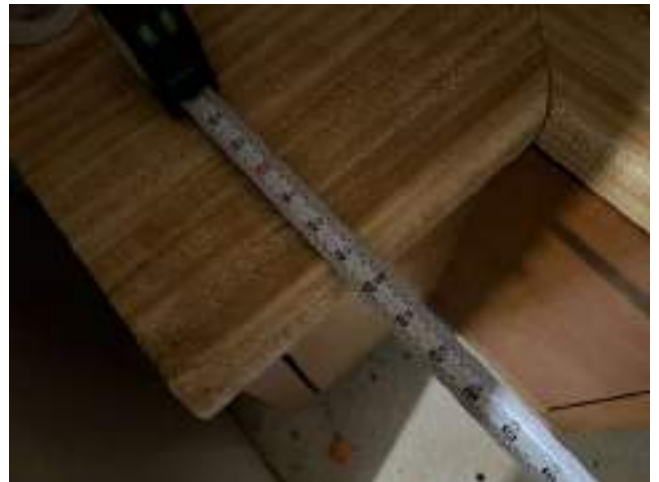
51. HDCP Unit 2601 Bld 9 2 Bed 1 Bath - Distance Between Range and Opposing Counter

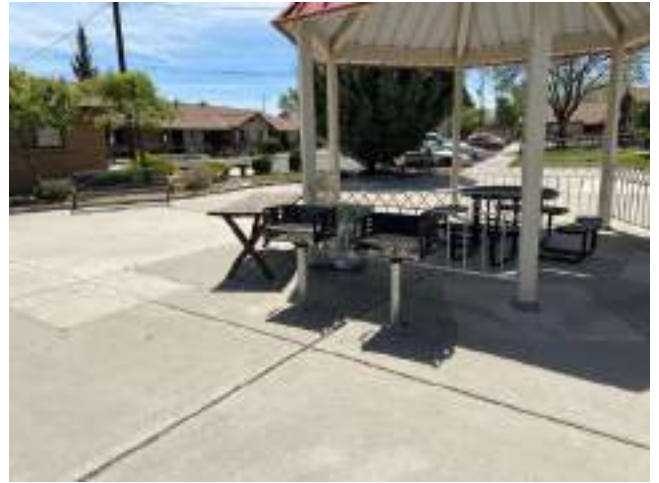
33. Barren Landscaping Near Building 7 (Non-Critical Repair)

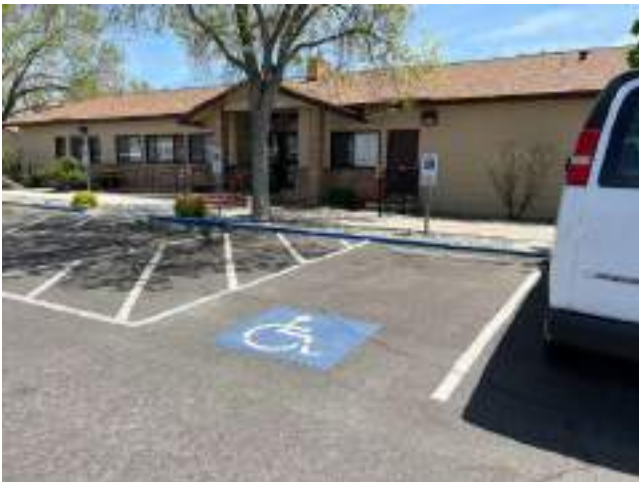
132. Construct Curb Cut to Sidewalk (Repair)
